## BENTHIC HABITAT ASSESSMENT REPORT

In support of the Environmental Assessment for the  
State Pier Infrastructure Improvements Project

AECOM  
500 Enterprise Drive  
Suite 1A  
Rocky Hill, Connecticut 06067

October 2, 2019

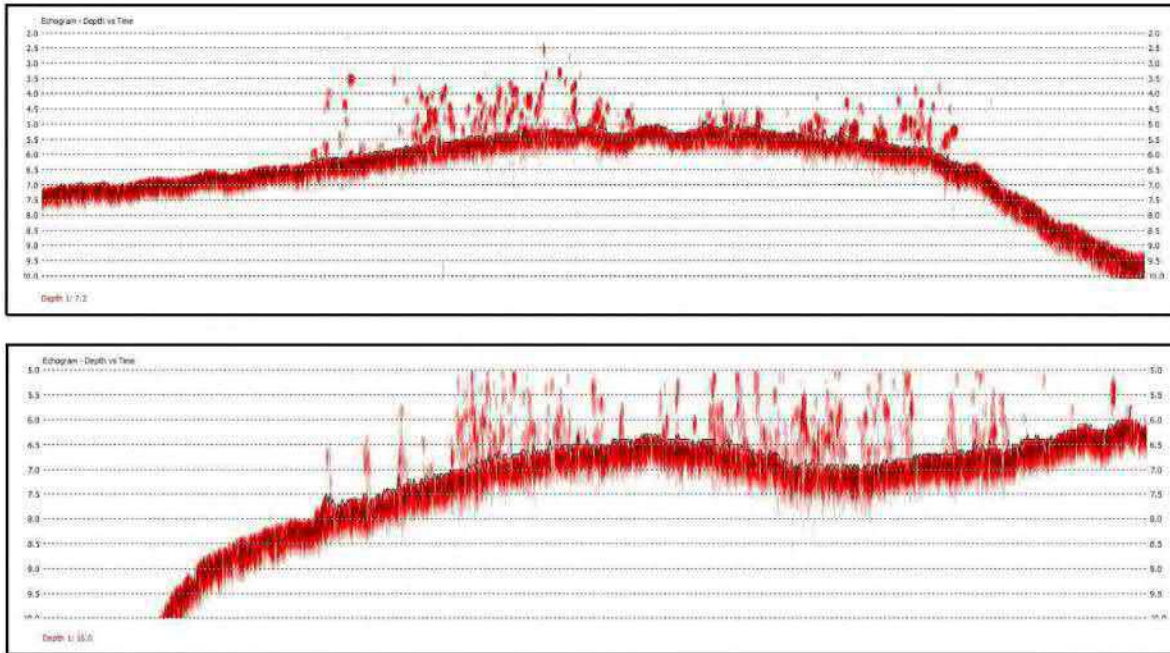
Figure 3-1 Echograms

www.crenvironmental.com	SAMPLE SINGLE-BEAM ECHOGRAMS NEW LONDON STATE PIER - July 25, 2019 New London, Connecticut	 
	NOTES: 1) Survey Conducted 7/25/2019 2) Grid CT State Plane NAD 83 US Feet 3) Single-beam track lines spaced 5-ft apart in eel grass area	Figure 3-1

Examination of the single beam trackline echograms indicated no SAV proximate to the New London State Pier Facility excluding lines off the northern portion of the northeast bulkhead near Winthrop Point. These echograms showed a distinct acoustic signature indicating patchy stands of SAV rising above the seabed (**Figure 3-1**). The narrow band of potential eelgrass was estimated to be approximately 4,600 ft.<sup>2</sup> (**Figures 3-2 and 3-3**).

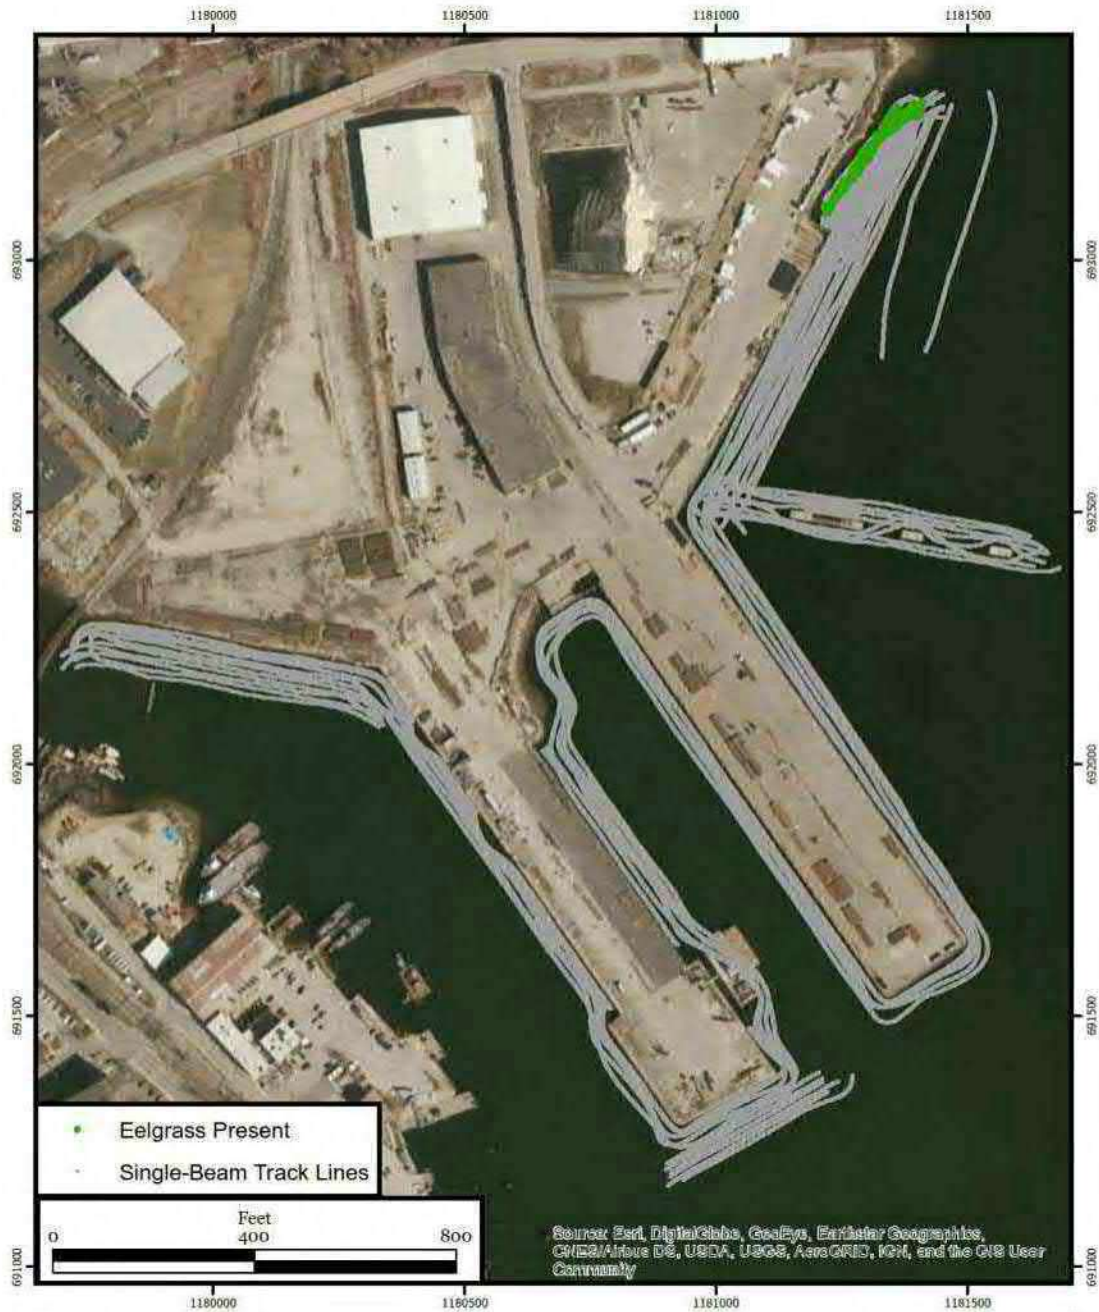
Figure 3-2 Echo Sounder Eelgrass Mapping

<a href="http://www.crenvironmental.com">www.crenvironmental.com</a>	<p><b>NEW LONDON STATE PIER</b>  <b>SINGLE BEAM - ECHO SOUNDER EELGRASS MAPPING</b>                  New London, Connecticut</p>	 
	<p><b>NOTES:</b>                  1) Survey conducted 7/25/2019                  2) Grid: CT State Plane NAD 83 US Feet                  3) Single-beam track lines spaced 10-ft apart around pier                  4) Single-beam track lines spaced 5-ft apart in Eelgrass area.</p>

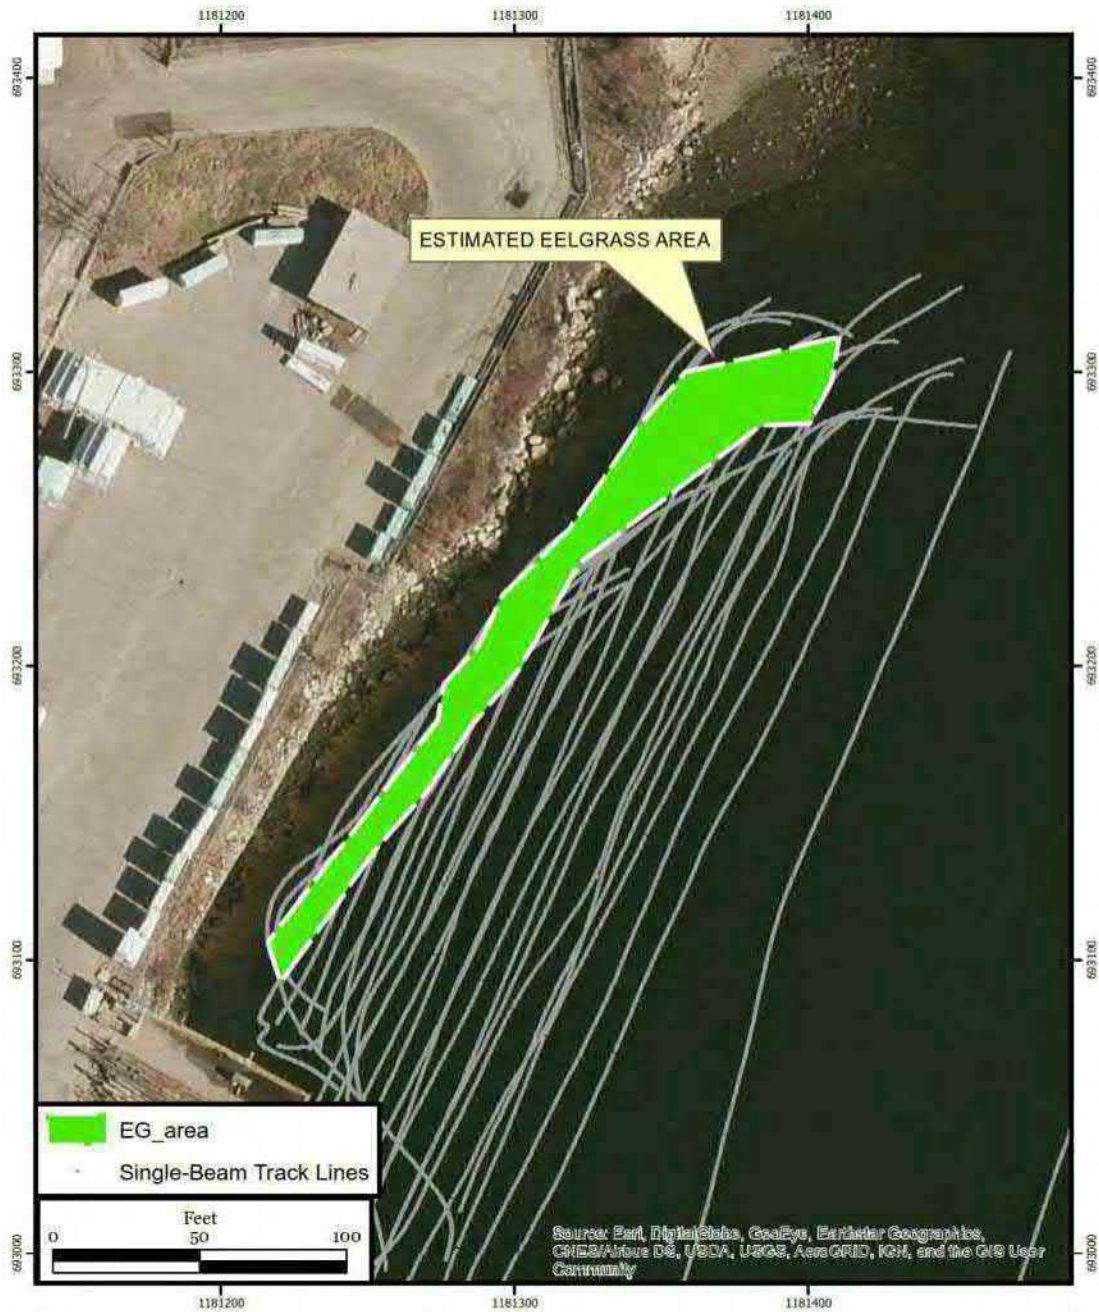
Figure 3-3 Northern Bulkhead Echo Sounder

<a href="http://www.cresenvironmental.com">www.cresenvironmental.com</a>	<p>NEW LONDON STATE PIER (NORTHEAST BULKHEAD) SINGLE BEAM - ECHO SOUNDER EELGRASS MAPPING New London, Connecticut</p>	 
	<p>NOTES:                  1) Survey conducted 7/25/2019                  2) Grid: CT State Plane NAD 83 US Feet                  3) Single-beam track lines spaced 10-ft apart around pier                  4) Single-beam track lines spaced 5-ft apart in Eelgrass area.</p>	<p>Figure 3-3</p>

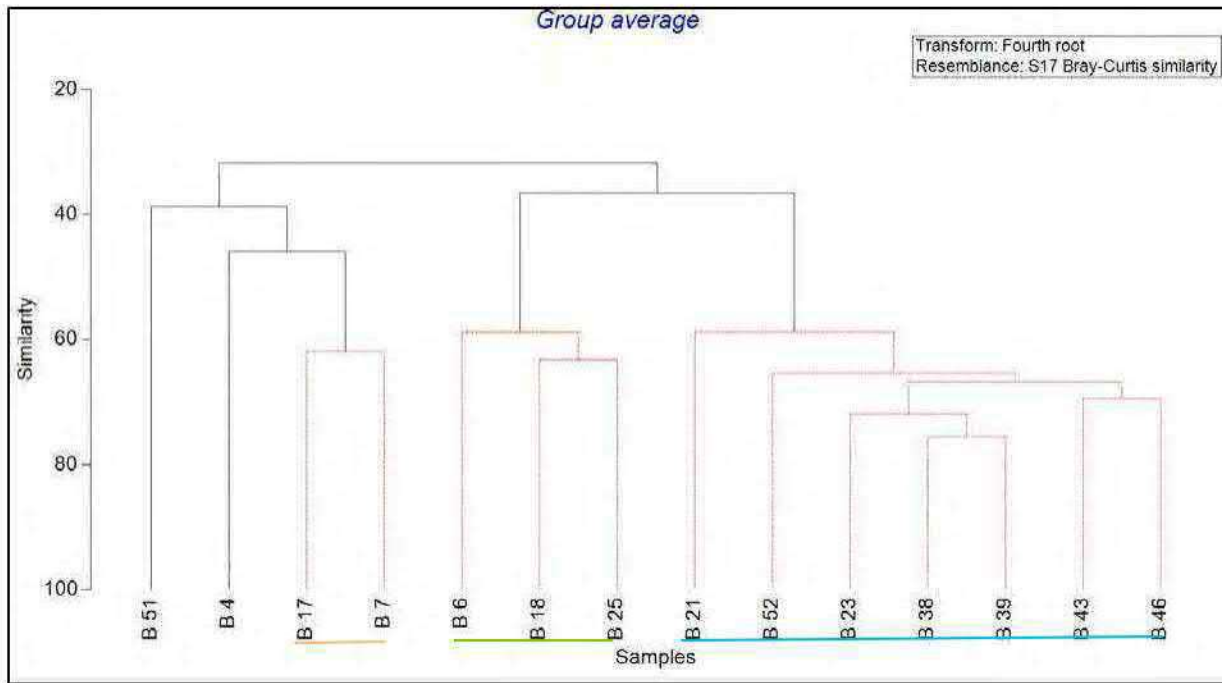
**Figure 3-6. Bray-Curtis Analysis at Family Level.**

The Bray-Curtis similarity analysis determined three distinct subgroups of stations and two outliers based on Family level taxonomic identifications. (Figure 3-6). There was no trend observed that correlated with sediment type being a factor to differentiate these groups. In general, the sediment at the stations sampled was comprised of black, silty mud indicative of anoxia and had sulfidic odor. This is also represented in the nMDS plot (Figure 3-7). The three main subgroups that were observed have different colored bars below. Stations B51 and B4 are considered outliers to these three main subgroups because they lacked correlation in taxa. Station B51 has a fewer Families when compared to the other stations. Also, the taxa at station B51 were comprised predominantly of Aoridae, Nassariidae and Corophiidae, which was dissimilar from the other station results. Station B51 was the only location sampled that had Nassariidae and Corophiidae in the top three taxa. Station B4 had higher abundances of Phyllodocidae and Myidae when compared to the other sample. Myidae were found with 94% of their abundance from Station B4. These differences in taxa separated station B4 from the other samples. Half of the station sampled (7) were grouped together based on abundances of Oligochaeta, Capitellidae and Yoldiidae (blue bar). The group comprised of Station B18, B25, and B21 (green bar) was a result of Ampharetids and Maldanidae presence. Station B7 and B17 were

grouped together (orange bar) based on presence of Lumbrineridae and the absence of other taxa found in the remaining samples.

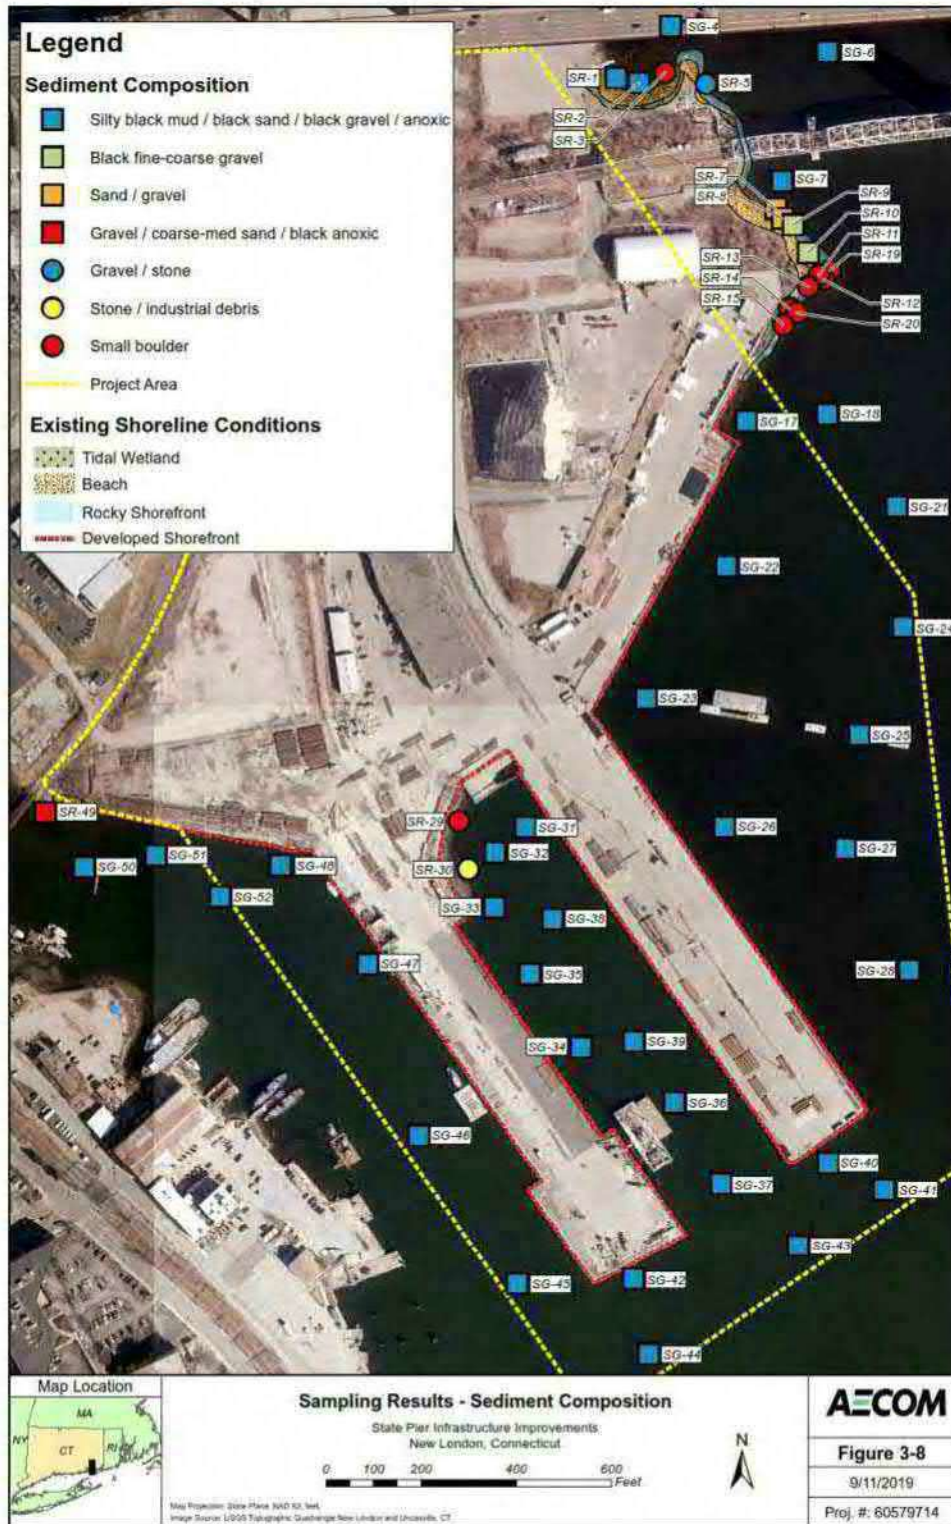
Figure 3-8 Sampling results – Sediment composition

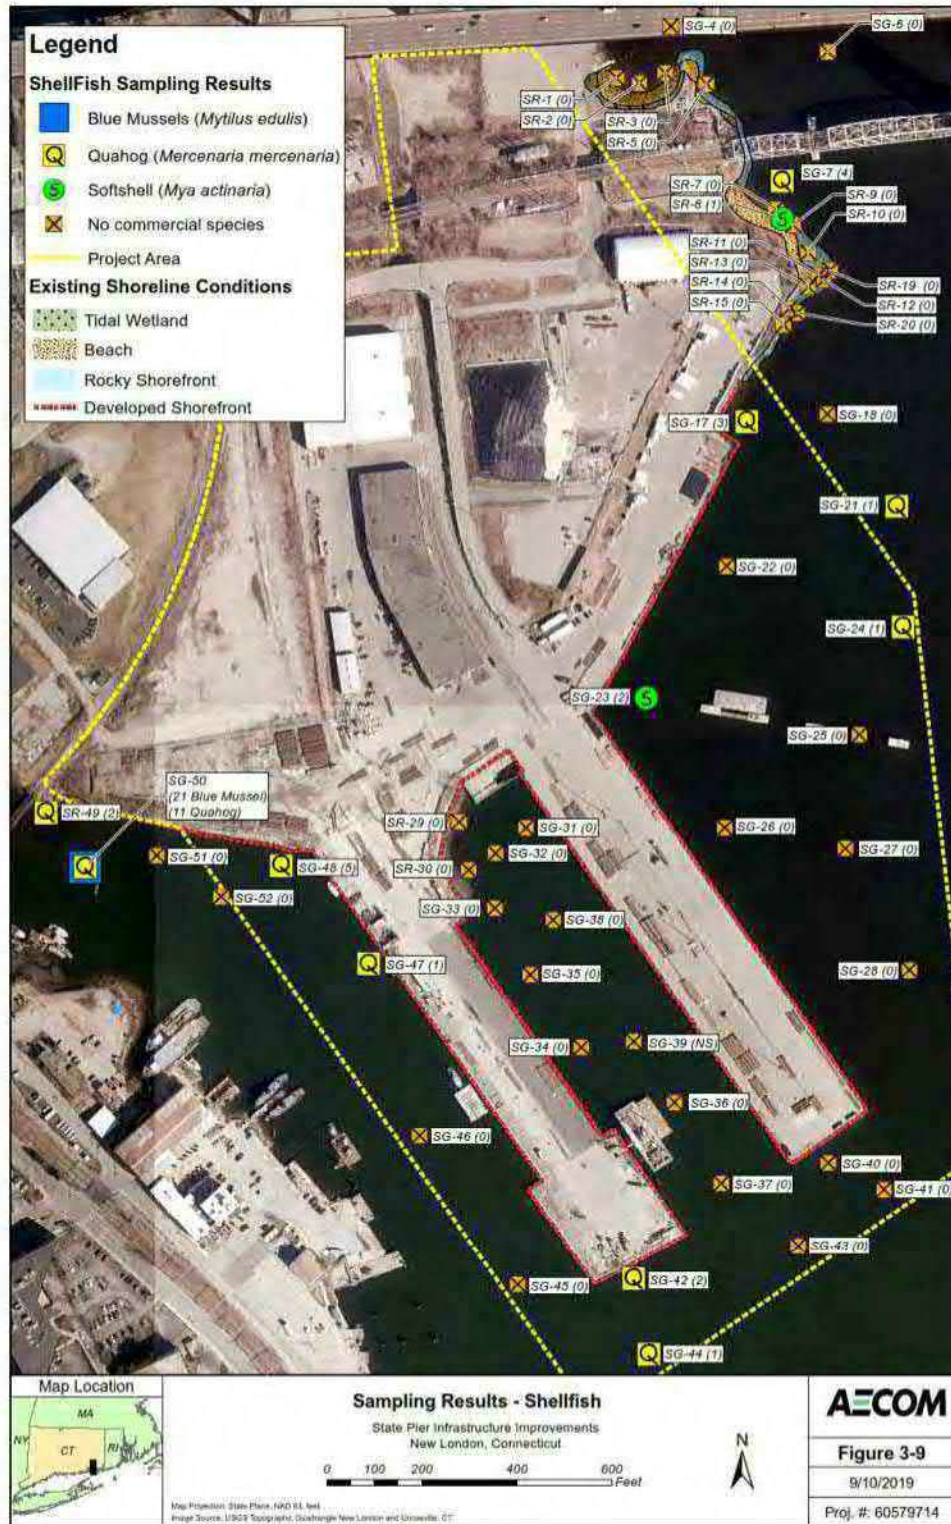
Figure 3-9 Sampling Results -Shellfish

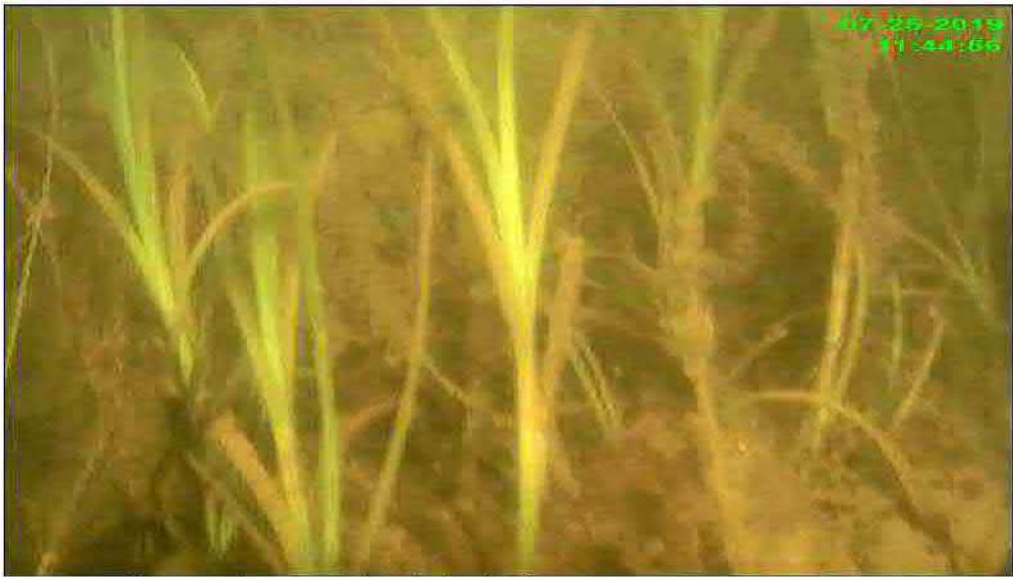
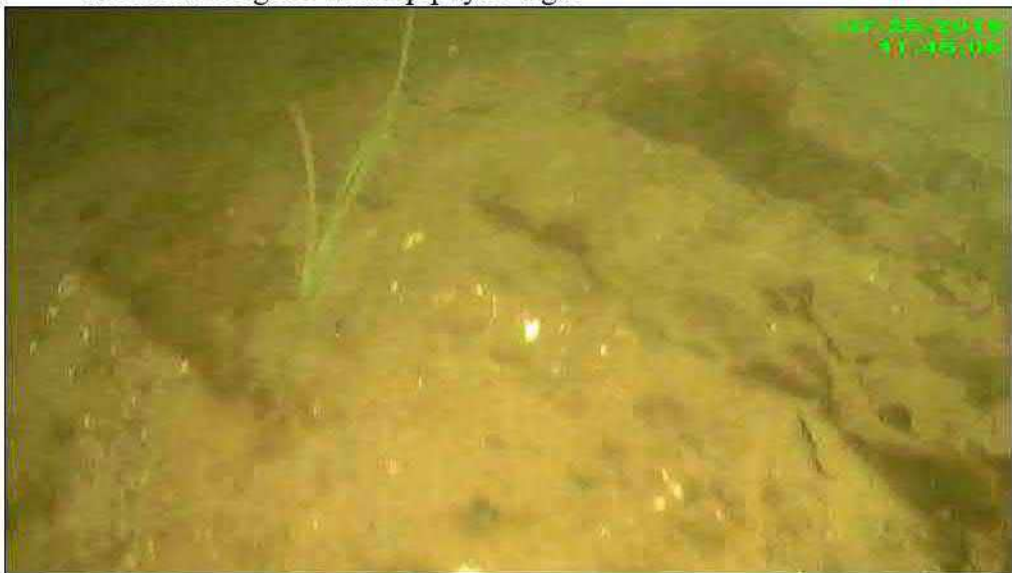
Moderate eelgrass with epiphytic algae

Sparse eelgrass on sand bottom

**Plate 1. Video Screen Captures of Bottom Substrate and Biota at TR-1 along northern portion of the Northeast Bulkhead**

The underwater video data confirmed the detected signal by the single beam echosounder at the northern extent of the survey area was eelgrass (*Zostera marina*). It was observed to be present in a narrow band along the northeast bulkhead near Winthrop Point. Eelgrass was observed at the inshore ends of video transects TR-1 through TR-4 and along the entire length of TR-5 that ran southwest directly through the narrow eelgrass stand (**Figure 2-2, Plates 1-4, 5A and B**).

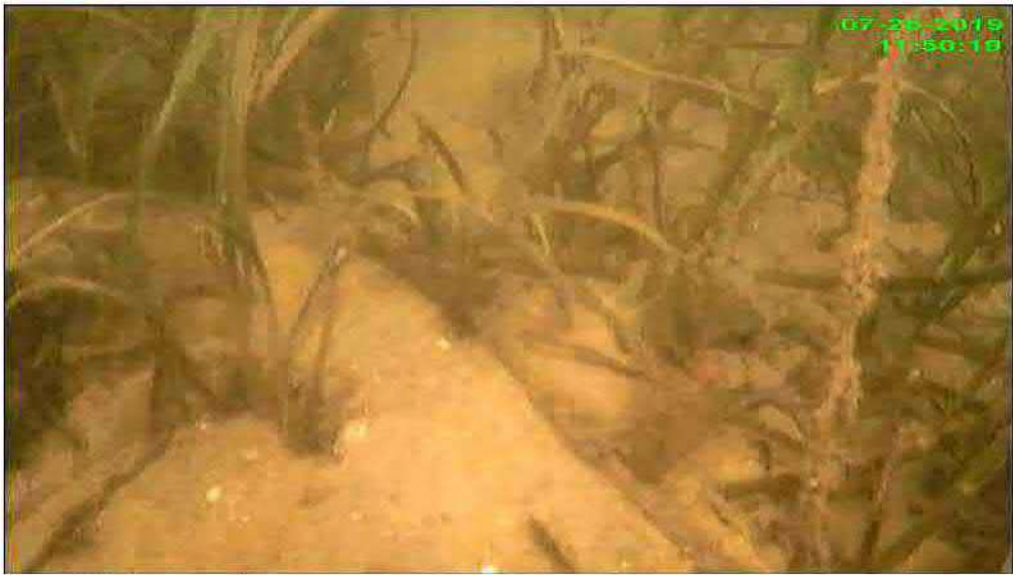
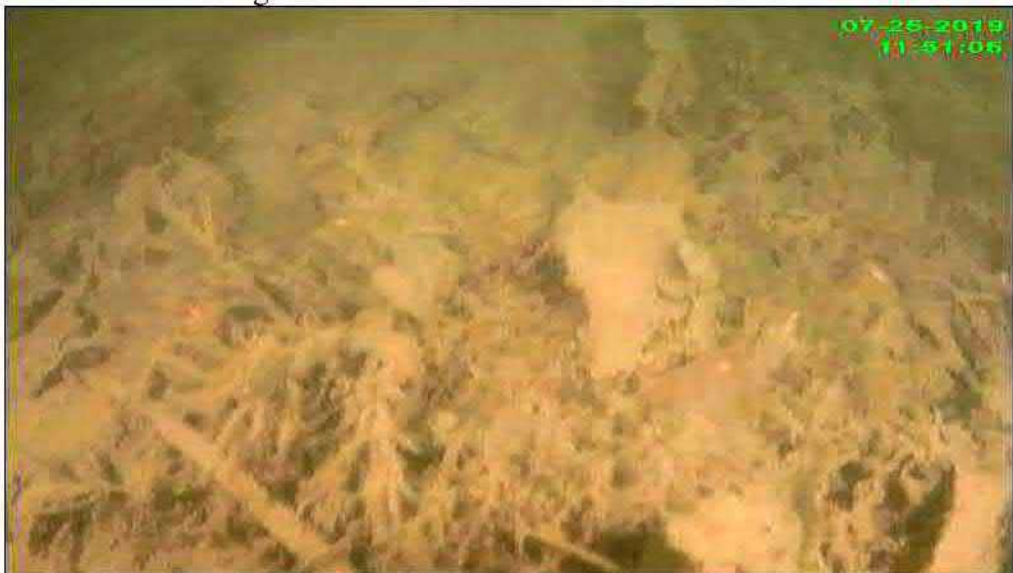
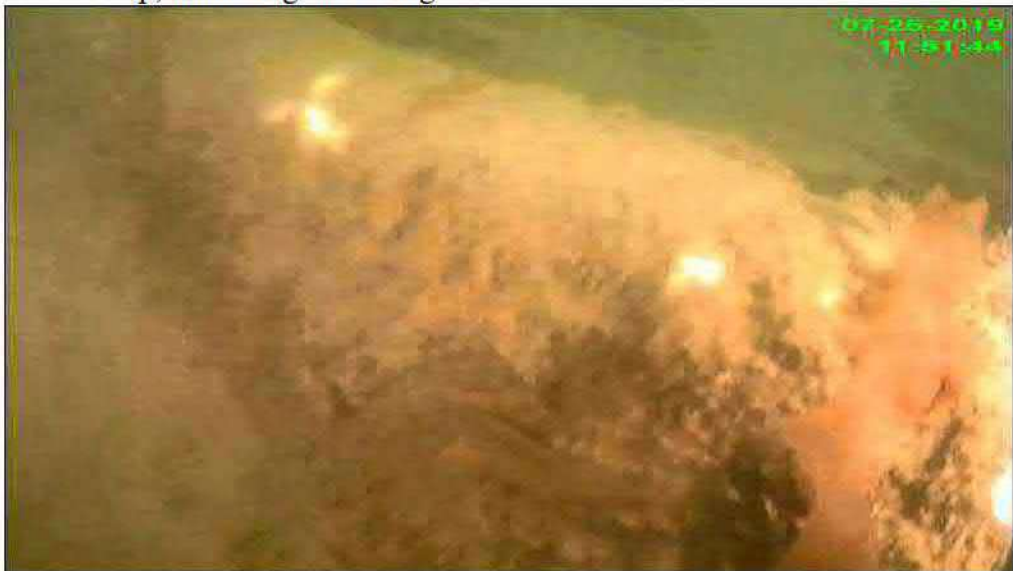
Moderate eelgrass

Kelp, branching brown algae

Wreckage, debris, purple laver

**Plate 2. Video Screen Captures of Bottom Substrate and Biota at TR-2 along the northern portion of the Northeast Bulkhead**

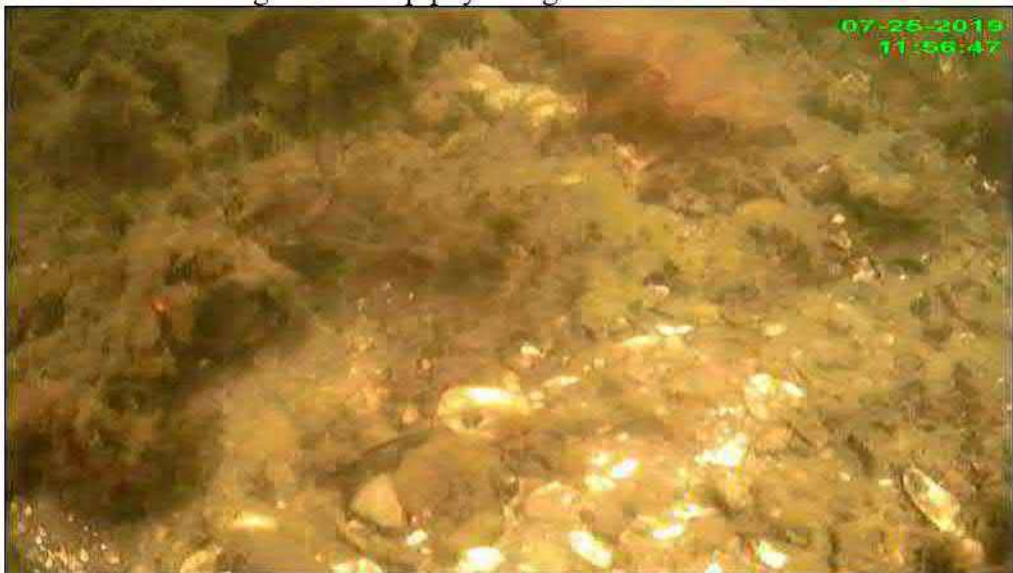
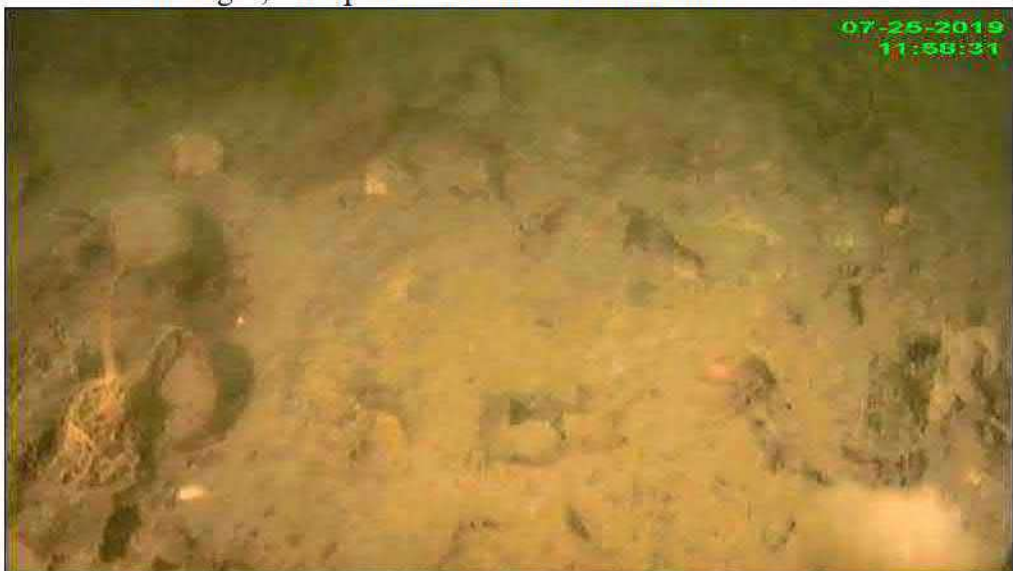
Moderate eelgrass with epiphytic algae

Macro Algae, sand/pebble bottom with shell hash

Kelp, sand bottom

**Plate 3. Video Screen Captures of Bottom Substrate and Biota at TR-3 along the northern portion of the Northeast Bulkhead near Winthrop Point**

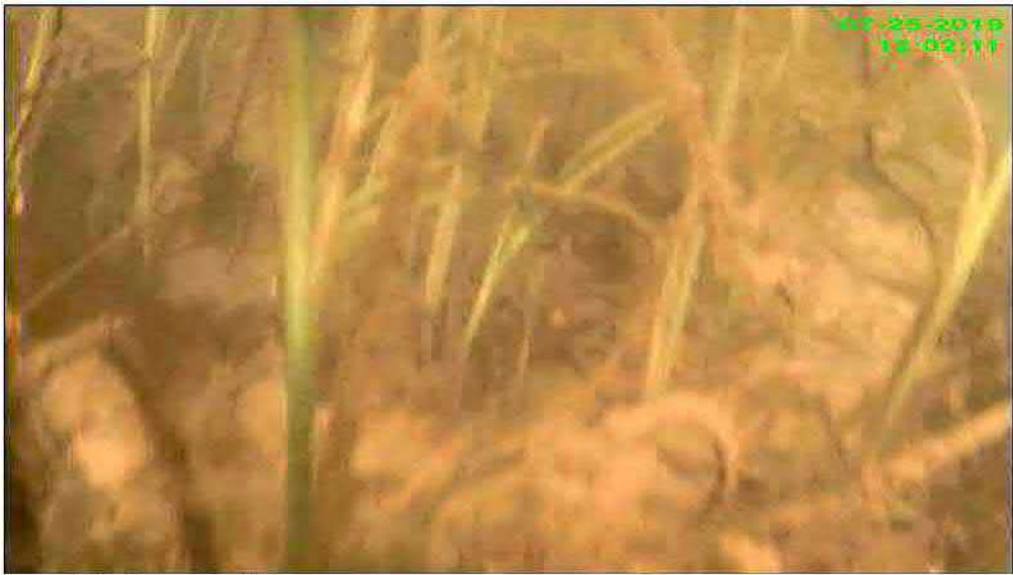
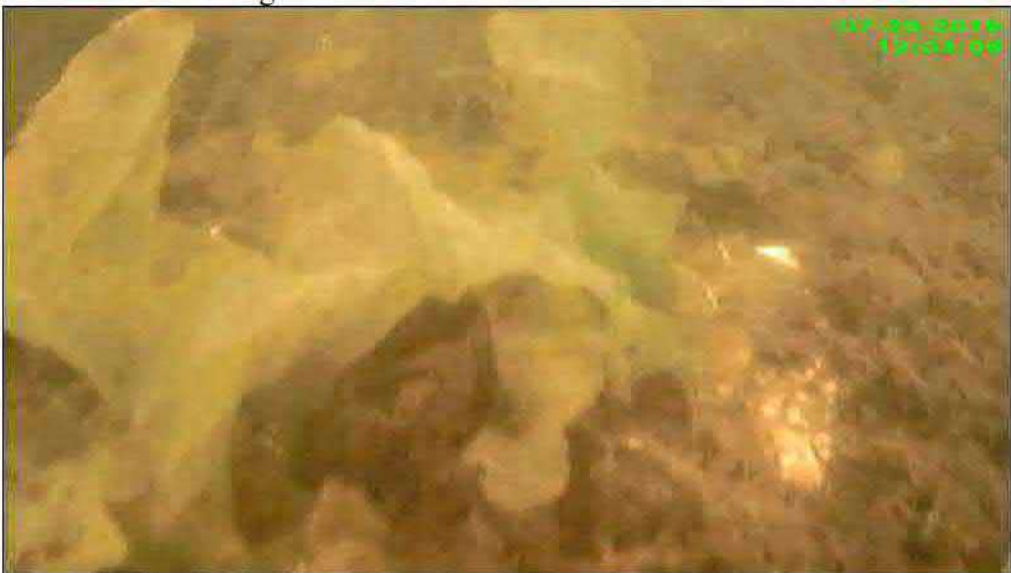
Moderate eelgrass

Sea lettuce, red branching algae

Kelp, purple laver

**Plate 4. Video Screen Captures of Bottom Substrate and Biota at TR-4 northern extent of Northeast Bulkhead**

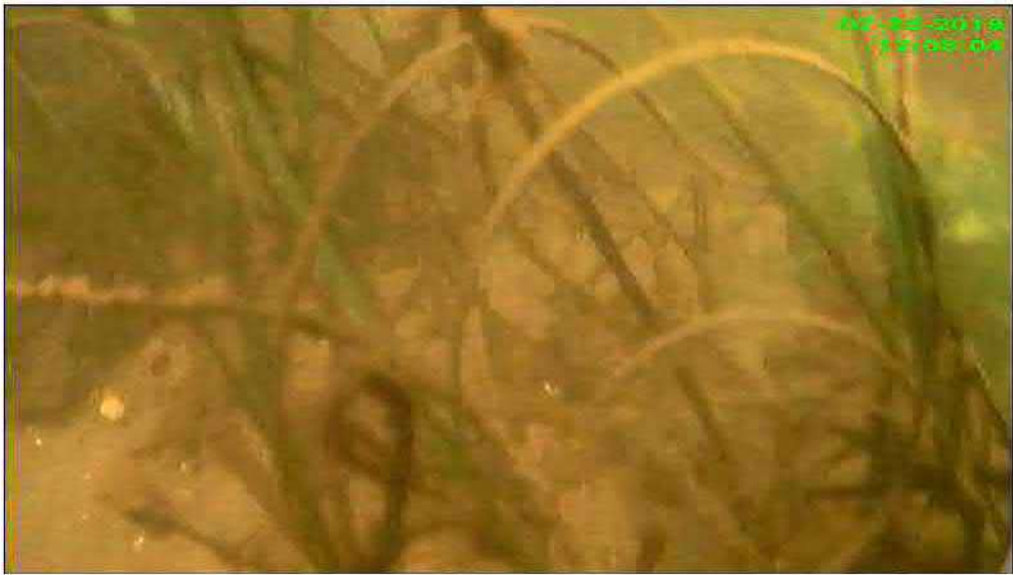
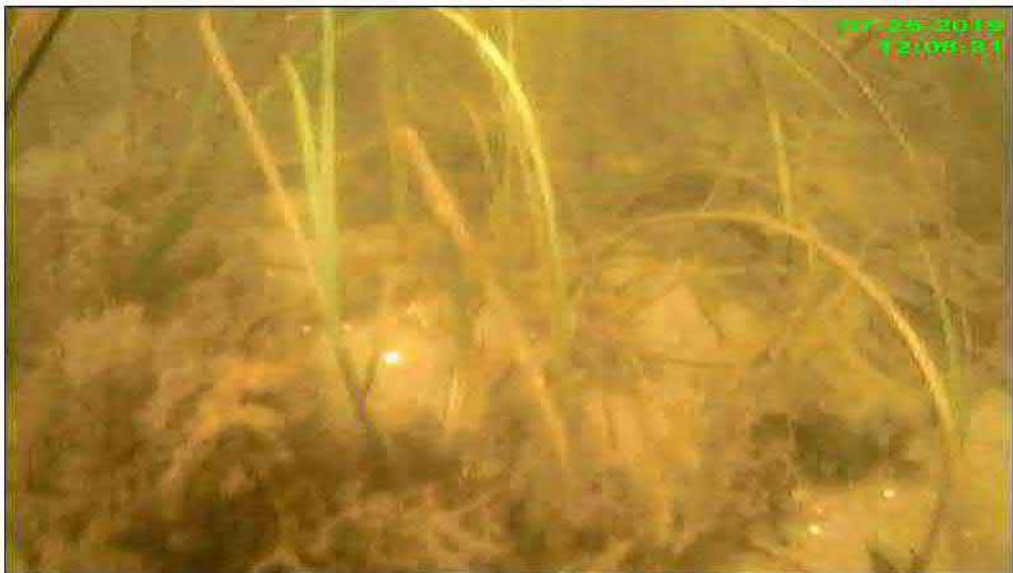
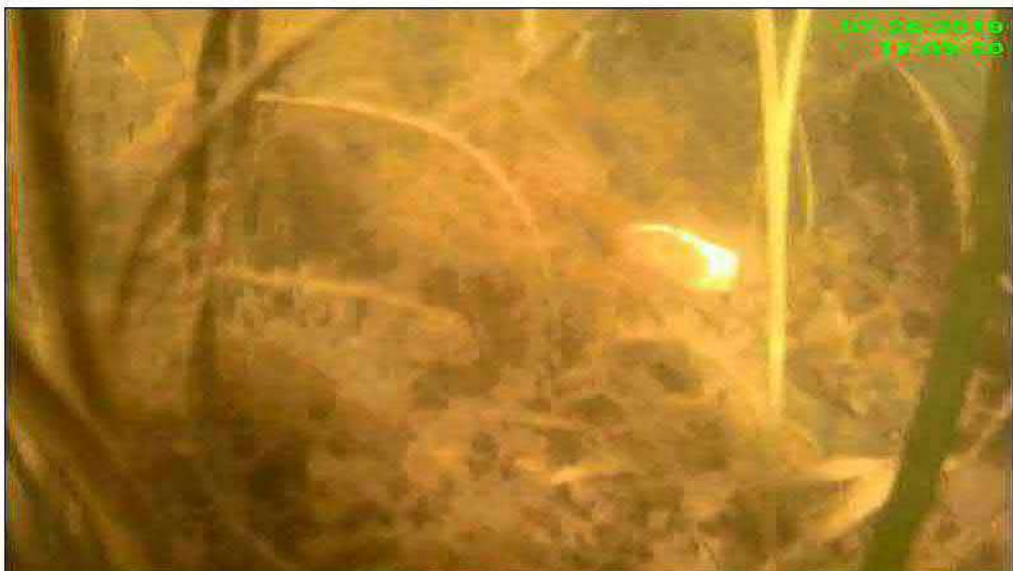
Moderate eelgrass with epiphytic algae

**Plate 5A. Video Screen Captures of Bottom Substrate and Biota at TR-5 through the eelgrass bed adjacent to the northern portion of the Northeast Bulkhead**

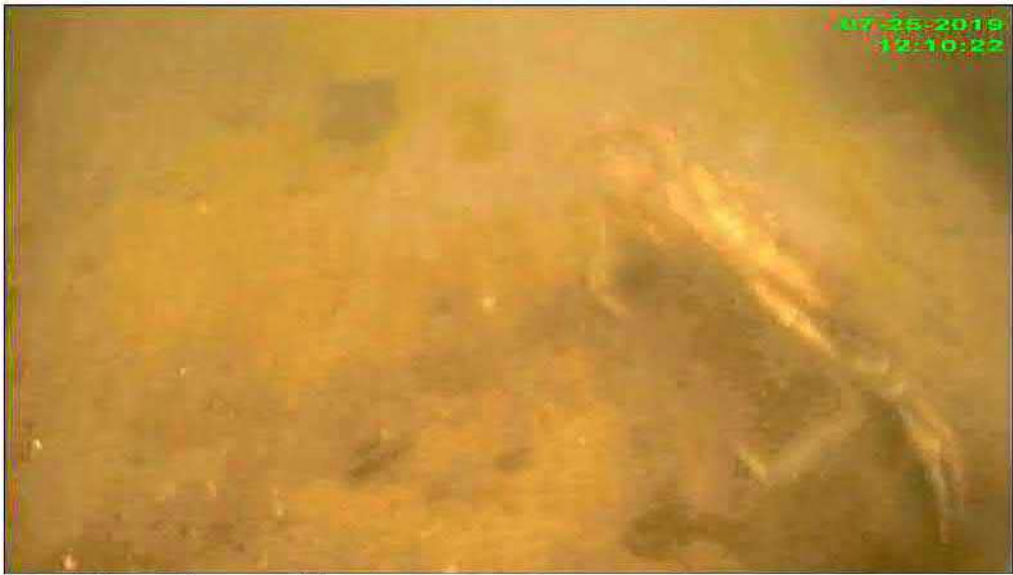
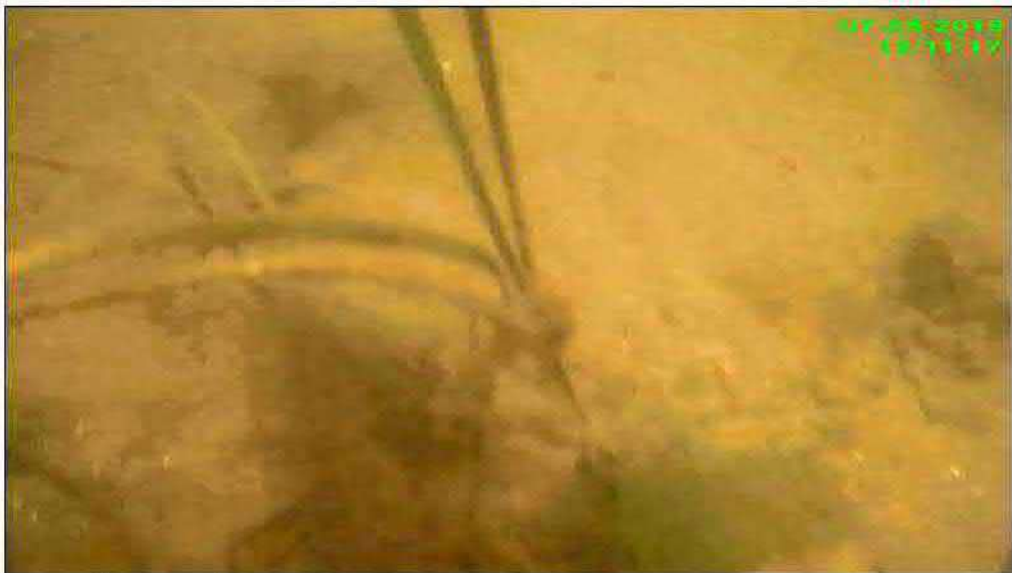
Blue crab on sand bottom

Sparse eelgrass

Moderate eelgrass with epiphytic algae

**Plate 5B. Video Screen Captures of Bottom Substrate and Biota at TR-5 through the eelgrass bed adjacent to the northern portion of the Northeast Bulkhead**

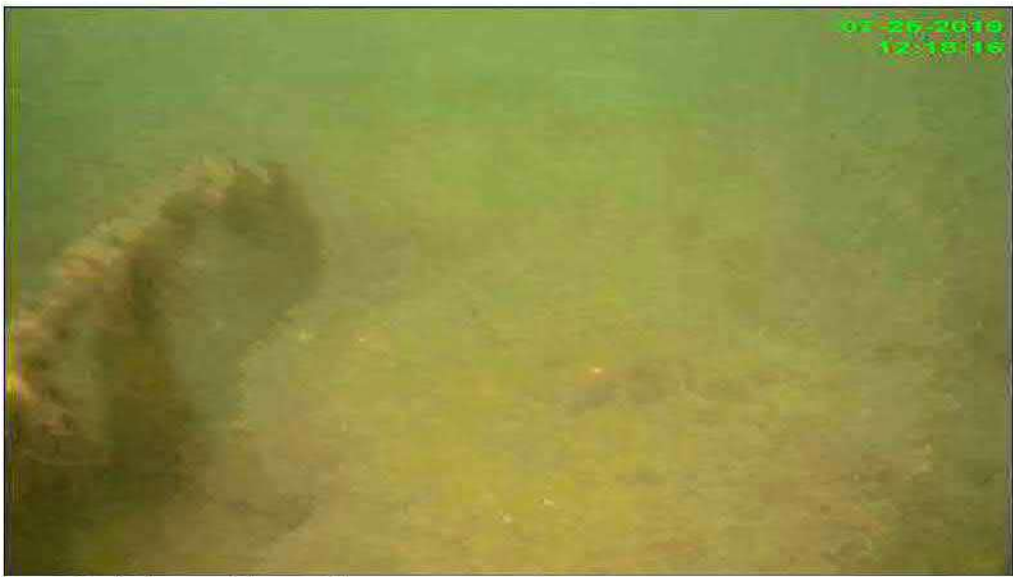
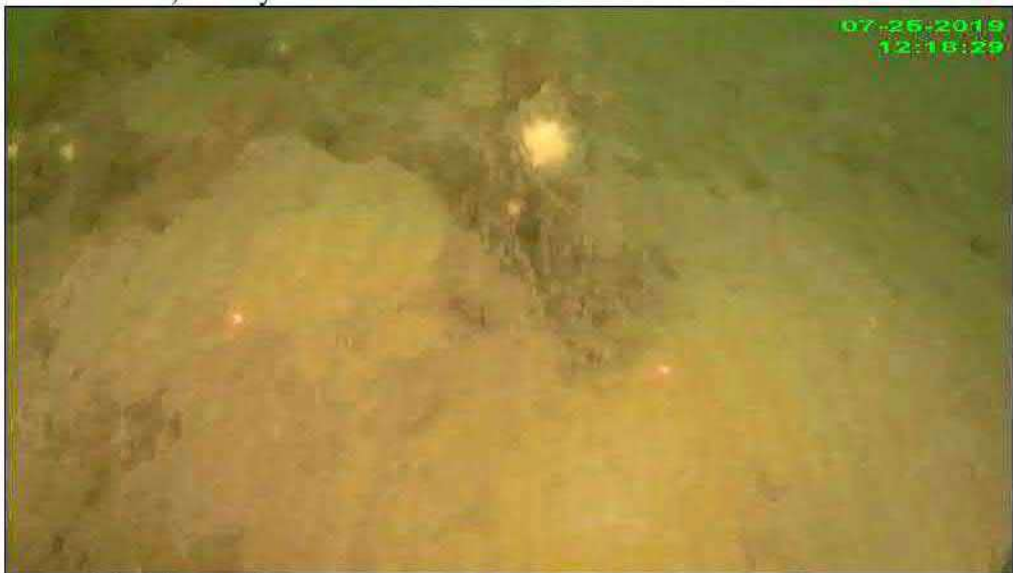
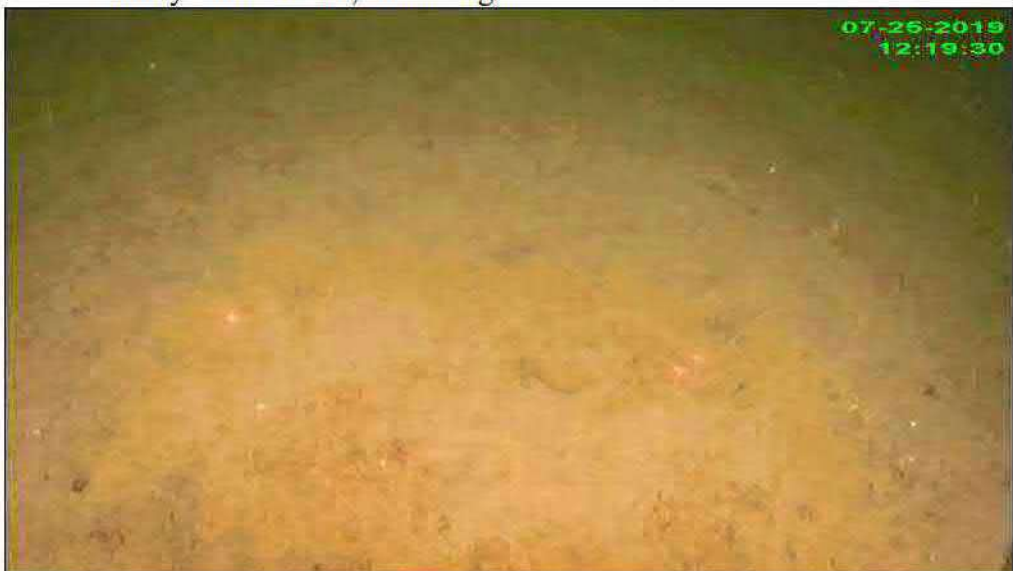
Debris, muddy sand bottom

Muddy sand bottom, macro algae

Muddy sand bottom

**Plate 6. Video Screen Captures of Bottom Substrate and Biota at TR-6 along the southern portion of the Northeast Bulkhead**

Industrial debris was observed from transect TR-6 located near the northeast bulkhead, transect TR-8 and transect TR-10 along the State Pier; therefore, only minimal video footage was obtained. No eelgrass was observed within the Project area. The substrate where eelgrass was observed outside the Project area was comprised of a sandy substrate (**Plate 1**). The substrate adjacent to the State Pier was characterized as a mix silty and sandy sediment (**Plate 8**). The sediment seafloor adjacent to CVRR Pier was comprised of sand and pebbles with shell hash interspersed (**Plates 12A and B, 13**). Areas of pebble, stones, and small boulders were observed along the northeastern and southwestern faces of the CVRR Pier. Along the northwest bulkhead sediment was characterized to be comprised of sand mixed with shell hash and silty sediment (**Plates 15A and B, 16**).

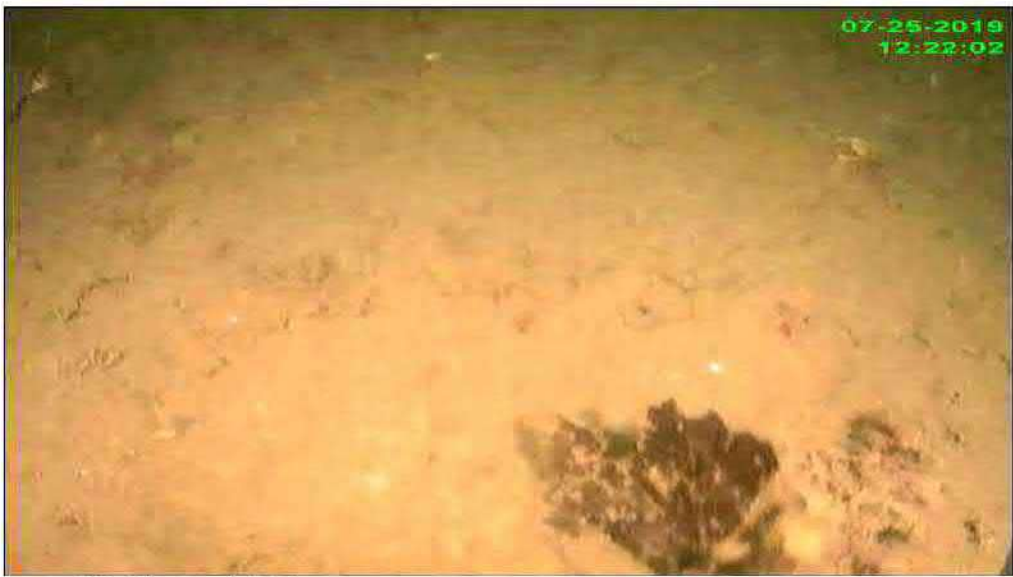
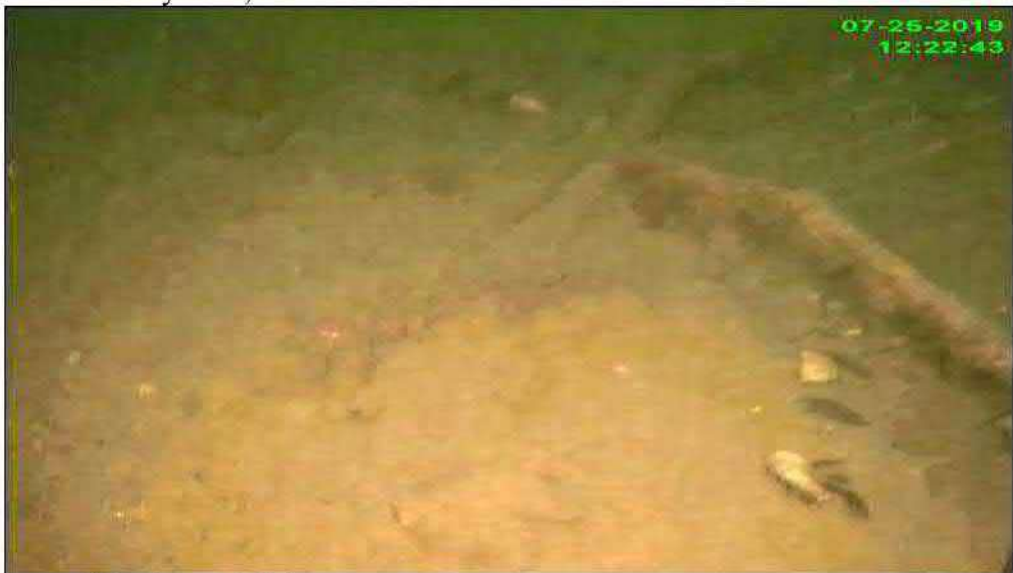
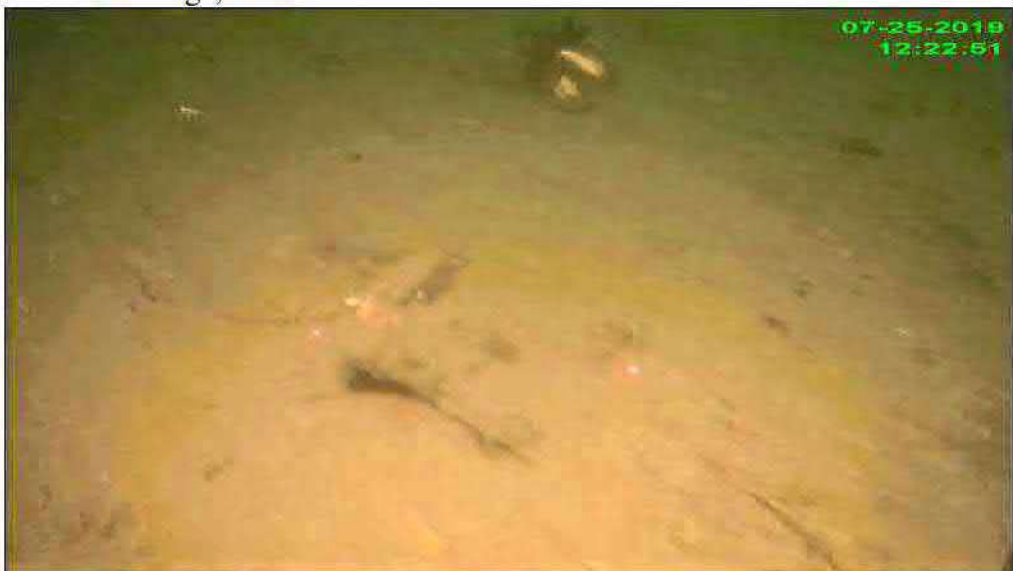
Muddy sand, Dulse

Wreckage, debris

Muddy sand bottom, blue mussels

**Plate 7. Video Screen Captures of Bottom Substrate and Biota at TR-7 at the southern end of the Northeast Bulkhead inshore of the Old Pier**

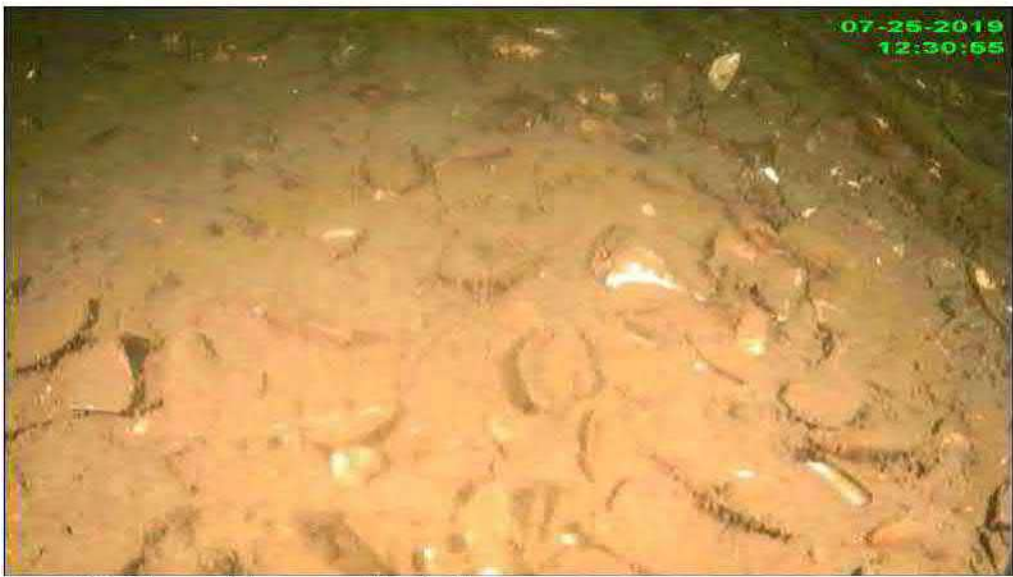
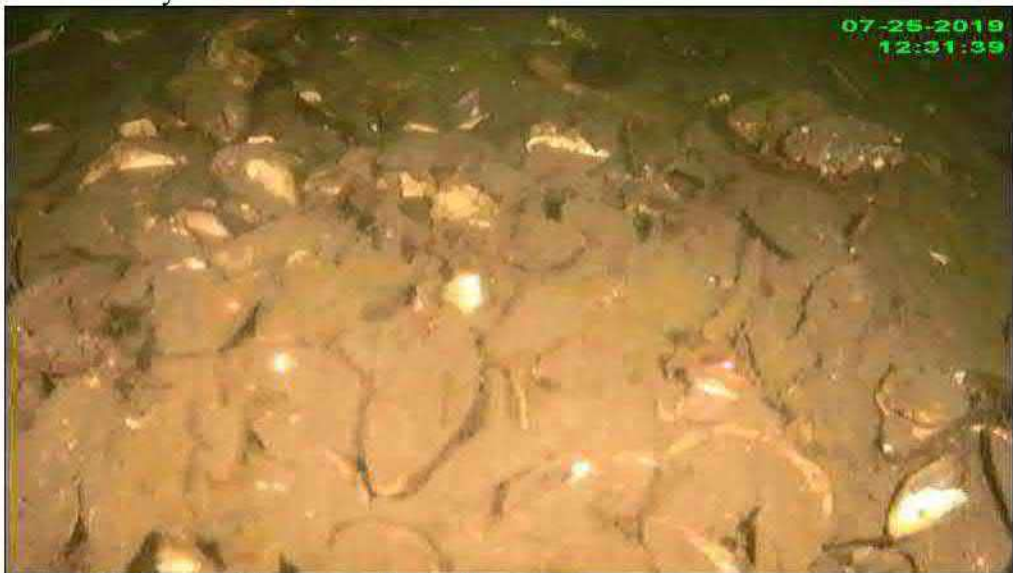
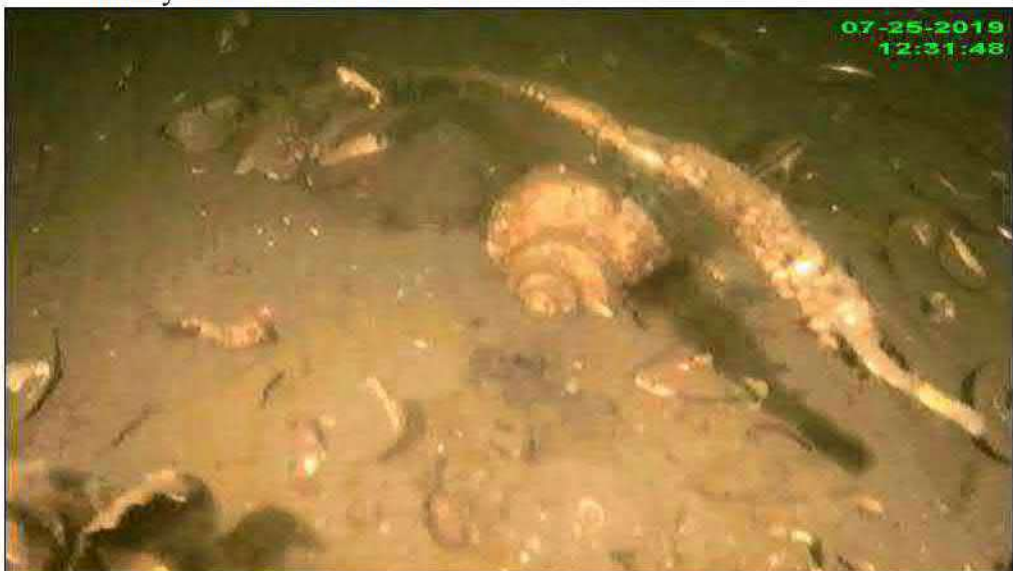
Muddy sand bottom with shell

Muddy sand, whelk, debris

**Plate 8. Video Screen Captures of Bottom Substrate and Biota at TR-9 along the southern end of the State Pier**
