## BENTHIC HABITAT ASSESSMENT REPORT

In support of the Environmental Assessment for the  
State Pier Infrastructure Improvements Project

AECOM  
500 Enterprise Drive  
Suite 1A  
Rocky Hill, Connecticut 06067

October 2, 2019

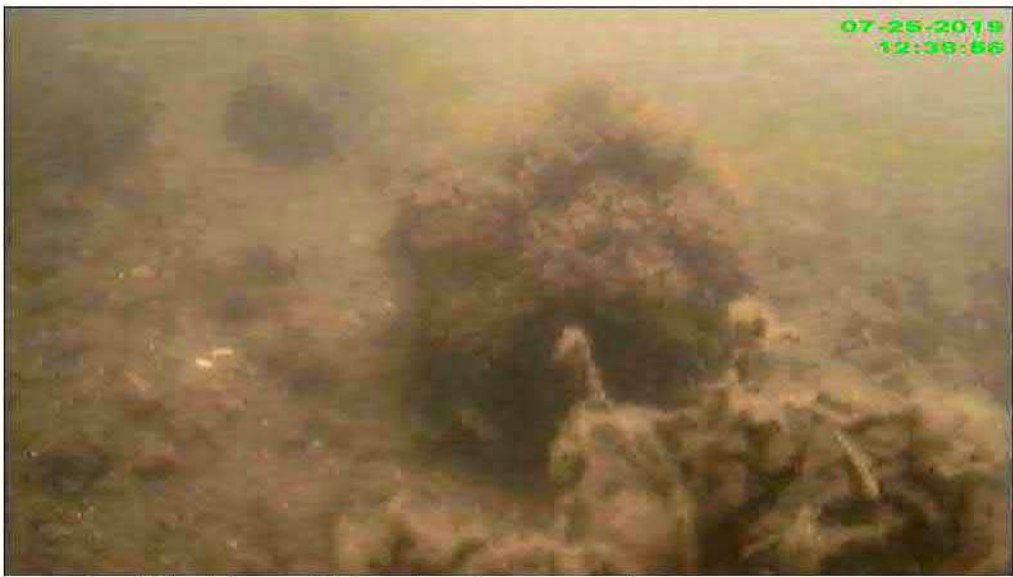
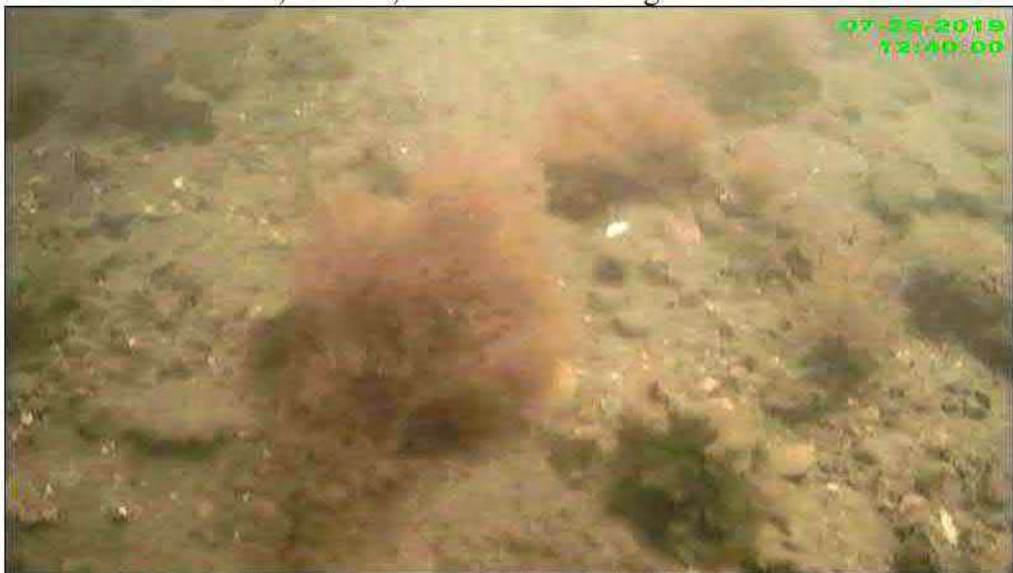
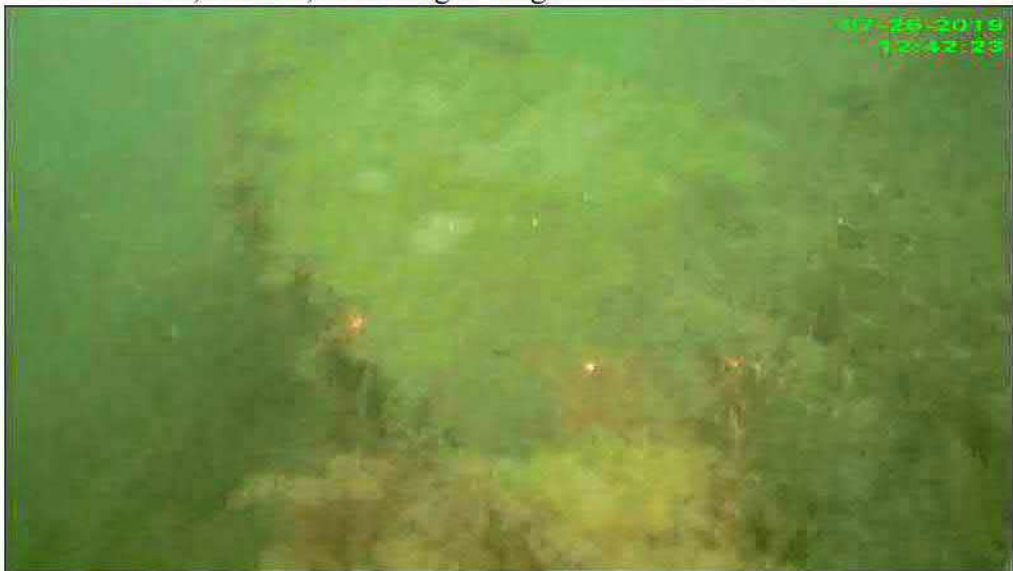
Small boulders, cobbles, abundant macro algae

Pebbles, cobbles, branching red algae

Wreckage, debris, macro algae

**Plate 9. Video Screen Captures of Bottom Substrate and Biota at TR-11 along riprap rubble nearshore end of the CVRR Pier**

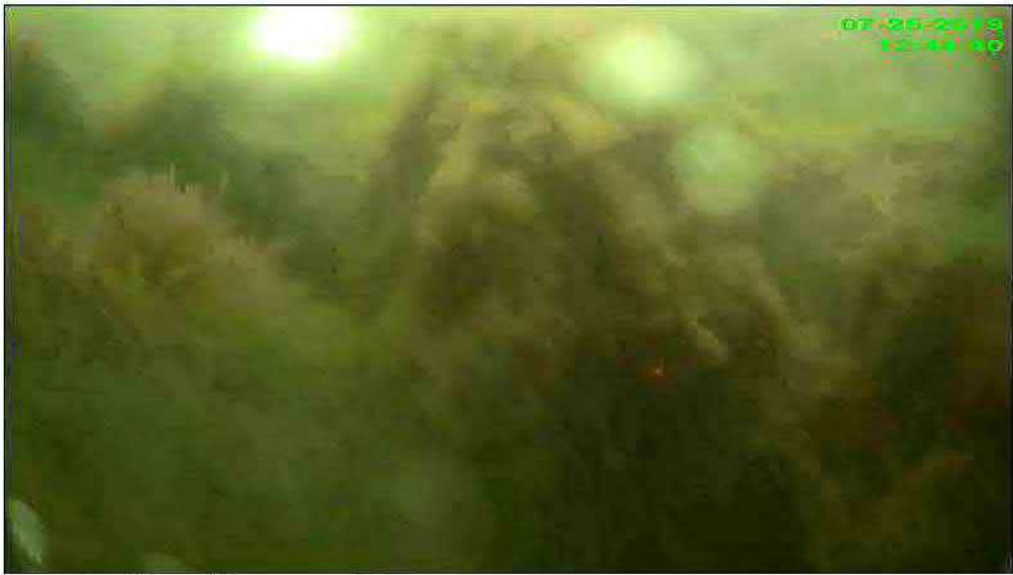
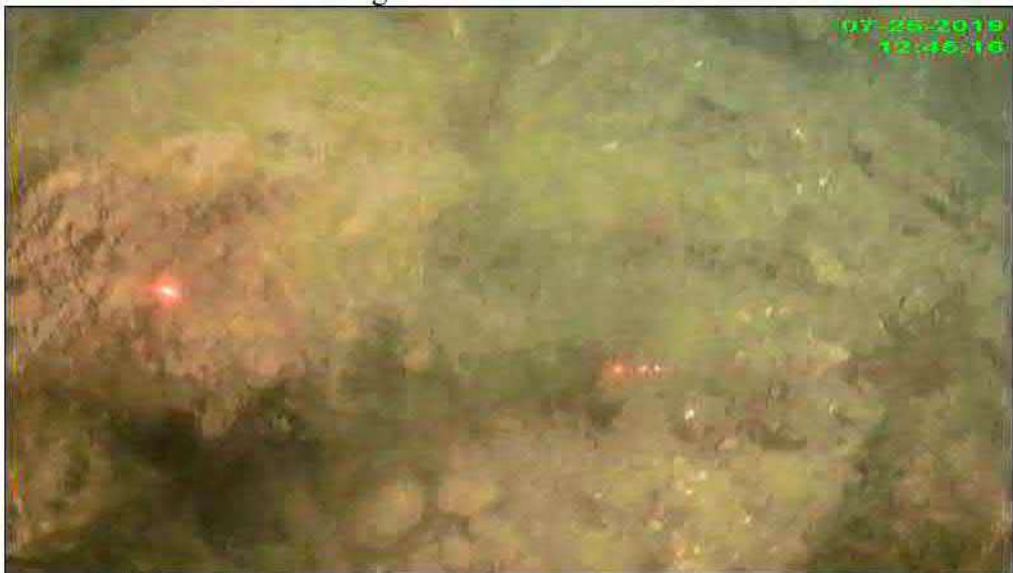
Boulder with macro algae

Pebble, cobble with macro algae

Muddy sand bottom with branching red algae

**Plate 10. Video Screen Captures of Bottom Substrate and Biota at TR-12 along the northeastern side of the CVRR Pier**

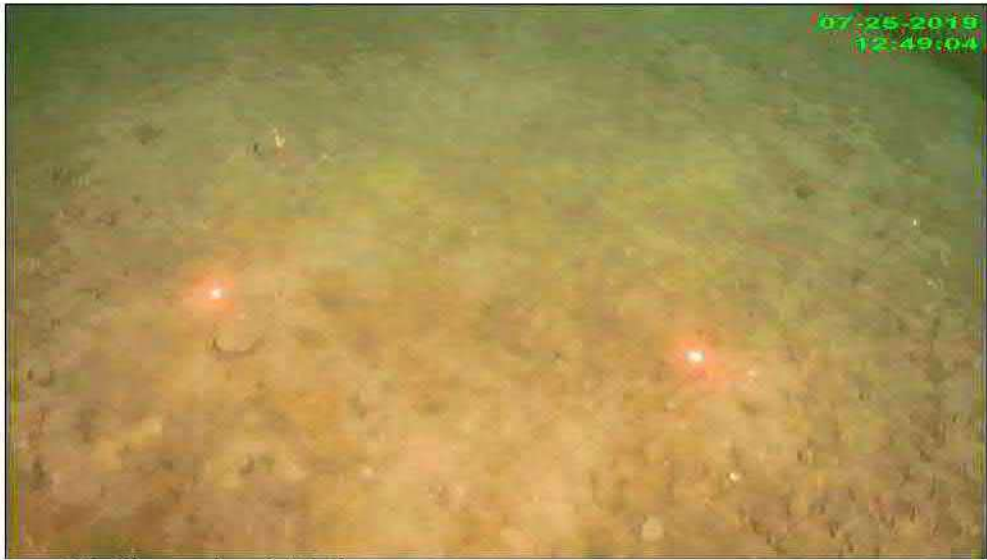
Muddy sand, pebble bottom

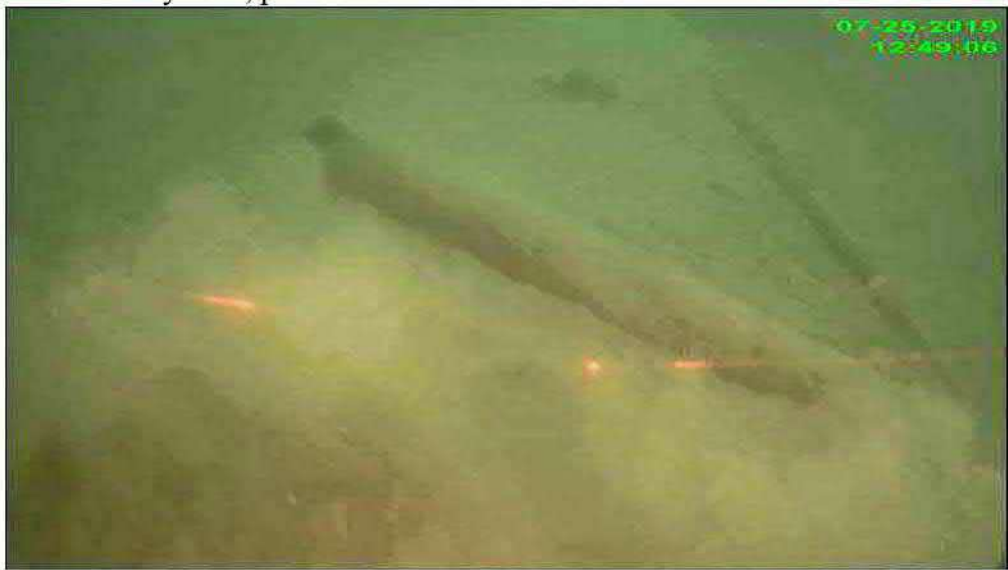
Wreckage, debris

Industrial debris was observed from transect TR-6 located near the northeast bulkhead, transect TR-8 and transect TR-10 along the State Pier; therefore, only minimal video footage was obtained. No eelgrass was observed within the Project area. The substrate where eelgrass was observed outside the Project area was comprised of a sandy substrate (**Plate 1**). The substrate adjacent to the State Pier was characterized as a mix silty and sandy sediment (**Plate 8**). The sediment seafloor adjacent to CVRR Pier was comprised of sand and pebbles with shell hash interspersed (**Plates 12A and B, 13**). Areas of pebble, stones, and small boulders were observed along the northeastern and southwestern faces of the CVRR Pier. Along the northwest bulkhead sediment was characterized to be comprised of sand mixed with shell hash and silty sediment (**Plates 15A and B, 16**).

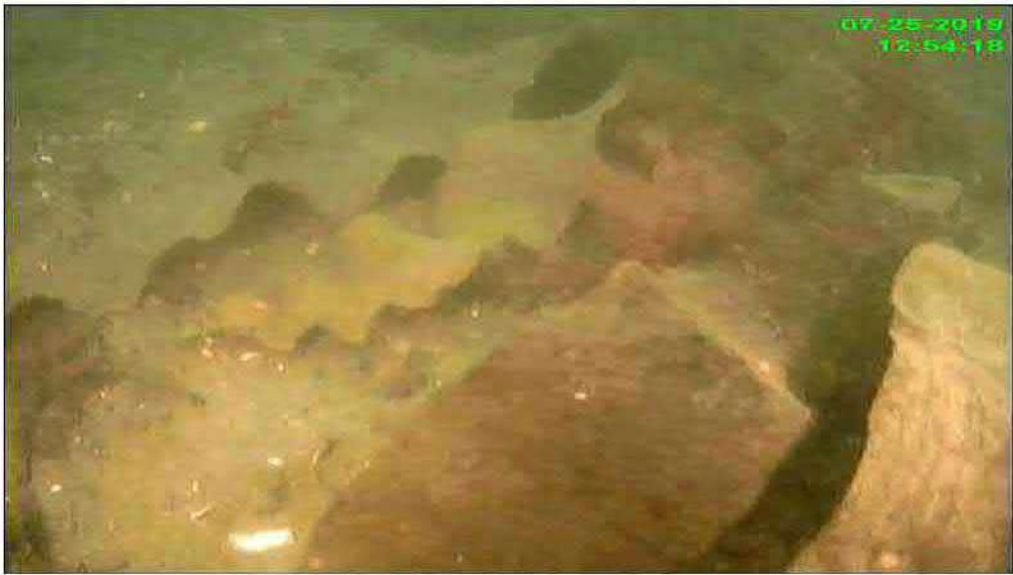
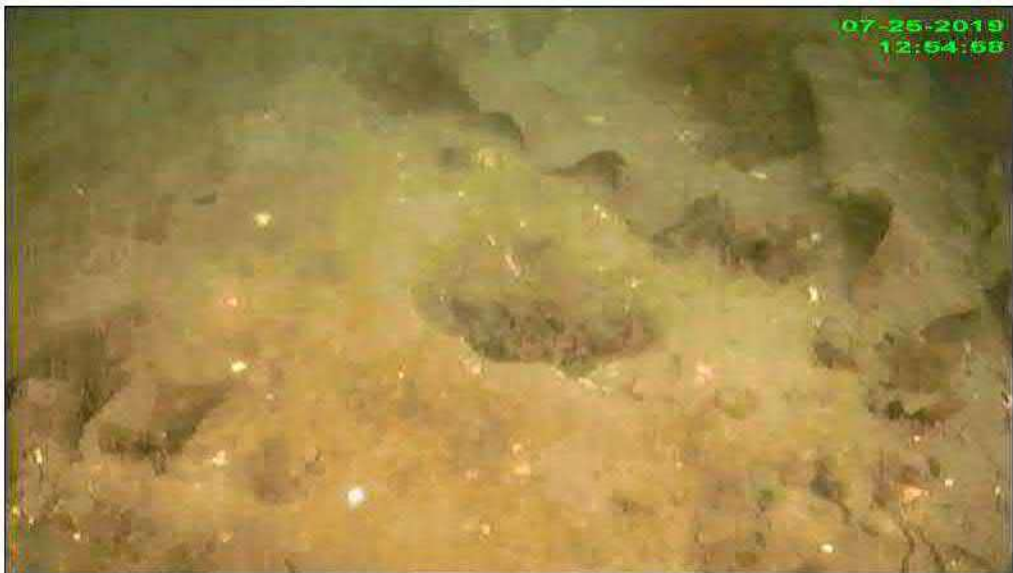
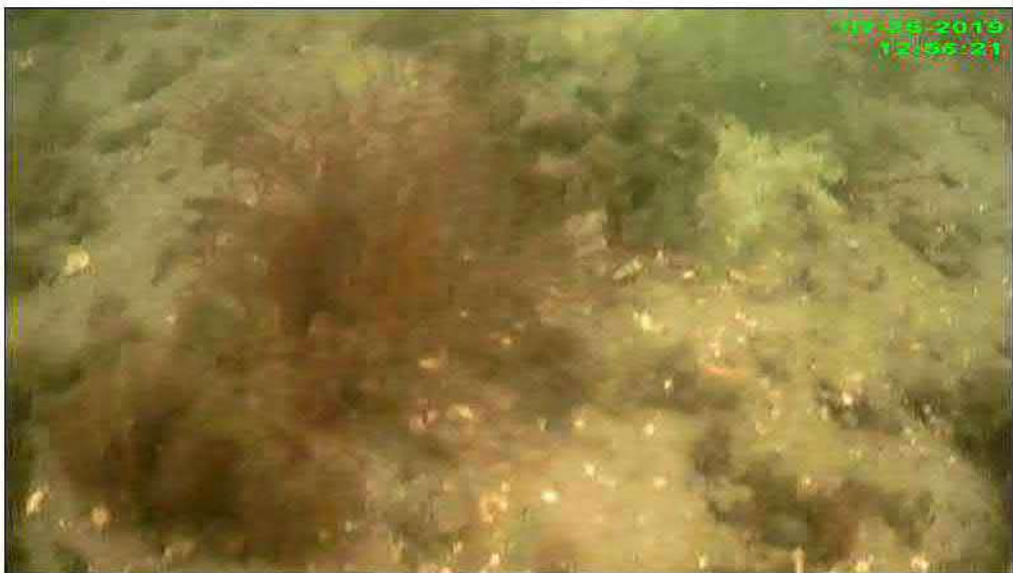
Kelp, red branching algae on a sand pebble bottom

**Plate 12A. Video Screen Captures of Bottom Substrate and Biota at TR-14 at the southern end of the CVRR Pier**

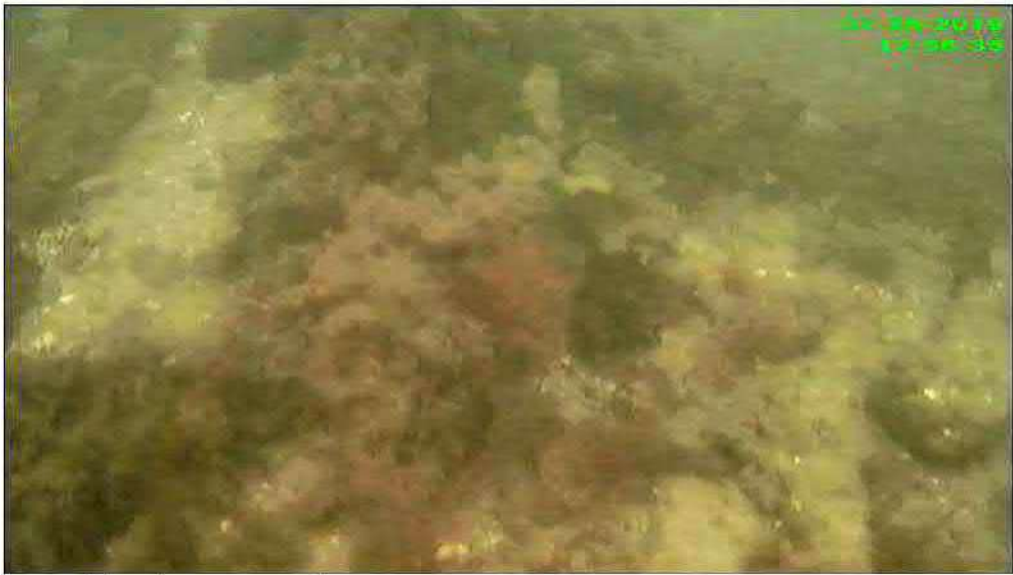
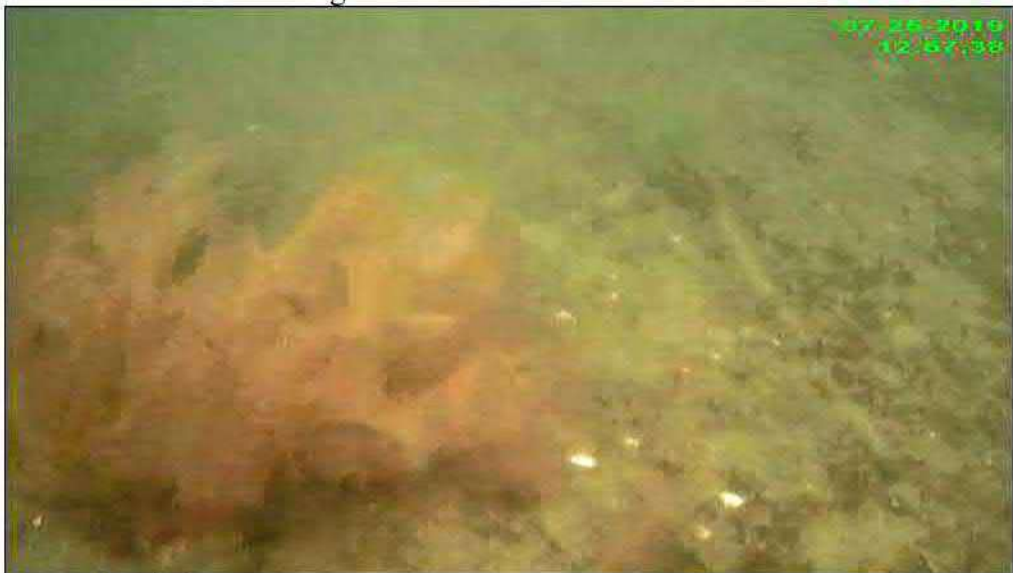
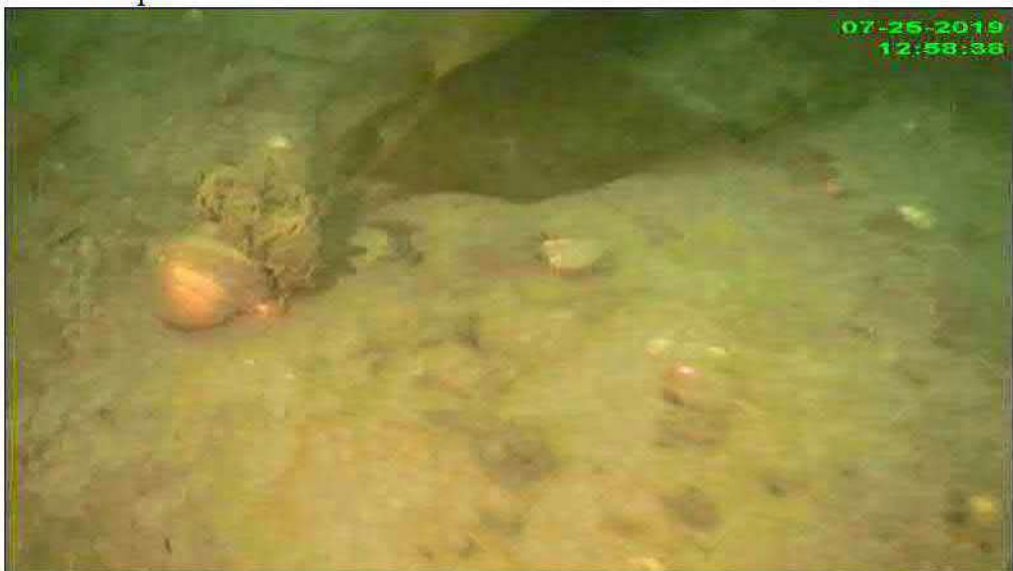
Abundant macro algae

Purple laver

Quahog, Kelp with hold fast

**Plate 12B. Video Screen Captures of Bottom Substrate and Biota at TR-14 at the southern end of the CVRR Pier**

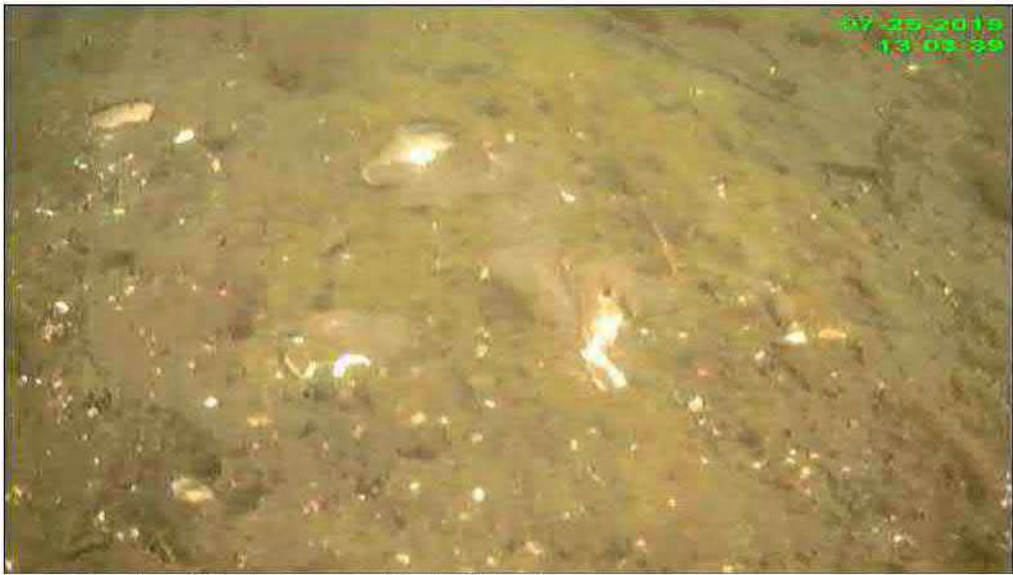
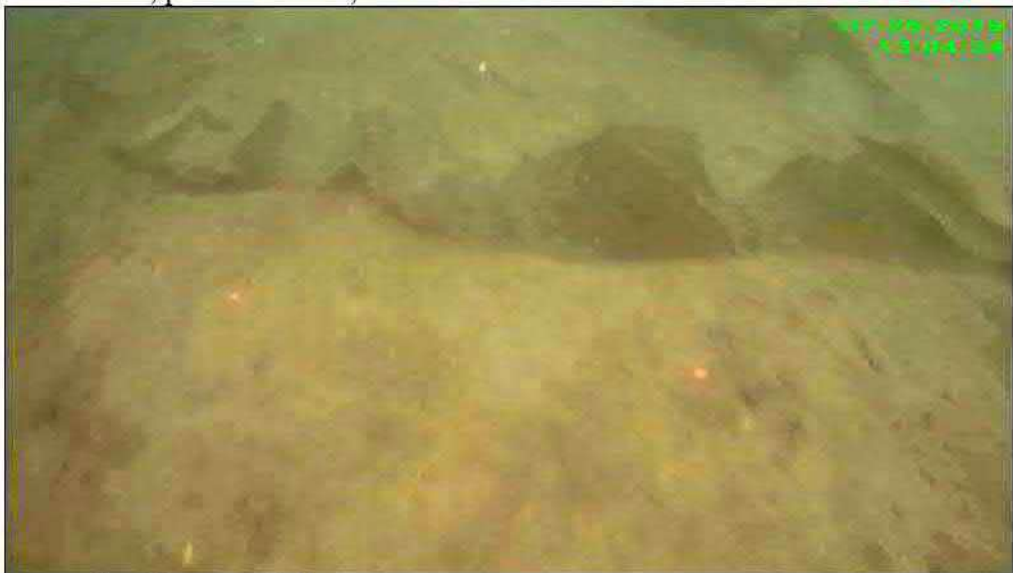
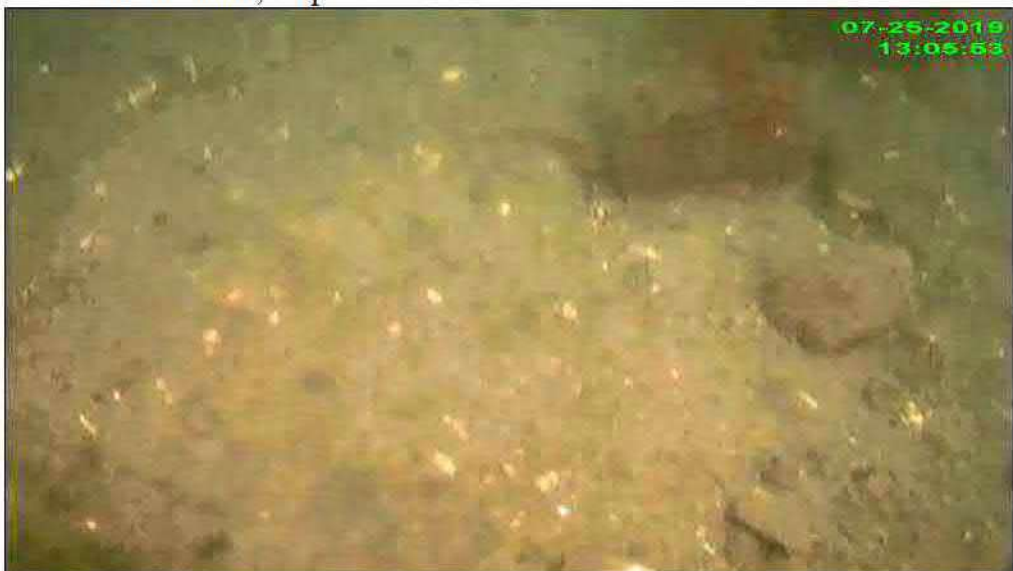
Sand, pebble bottom, with shell hash

Sand bottom, kelp

Sand, pebble bottom, purple laver

**Plate 13. Video Screen Captures of Bottom Substrate and Biota at TR-15 along the southwest side of the CVRR Pier**

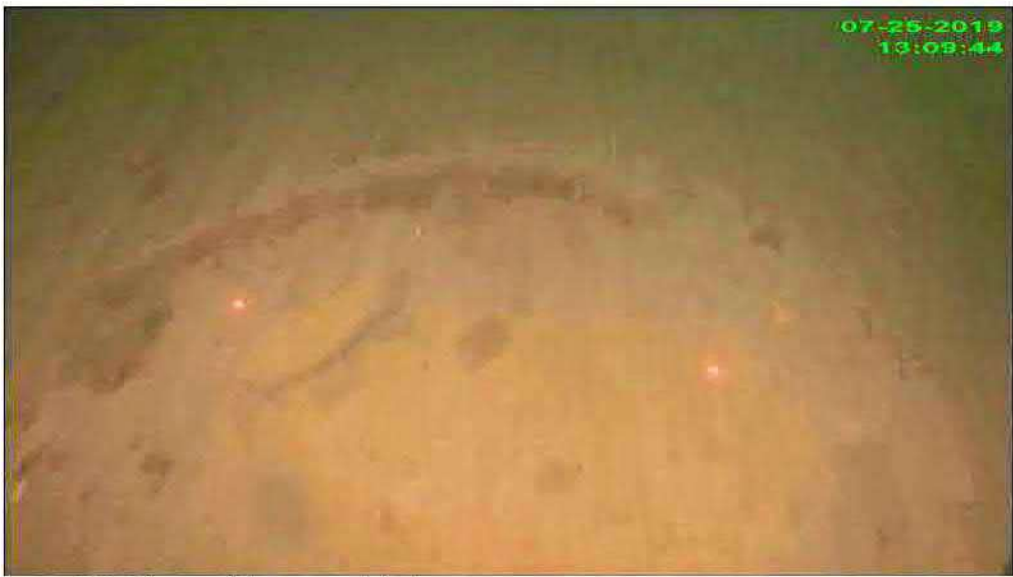
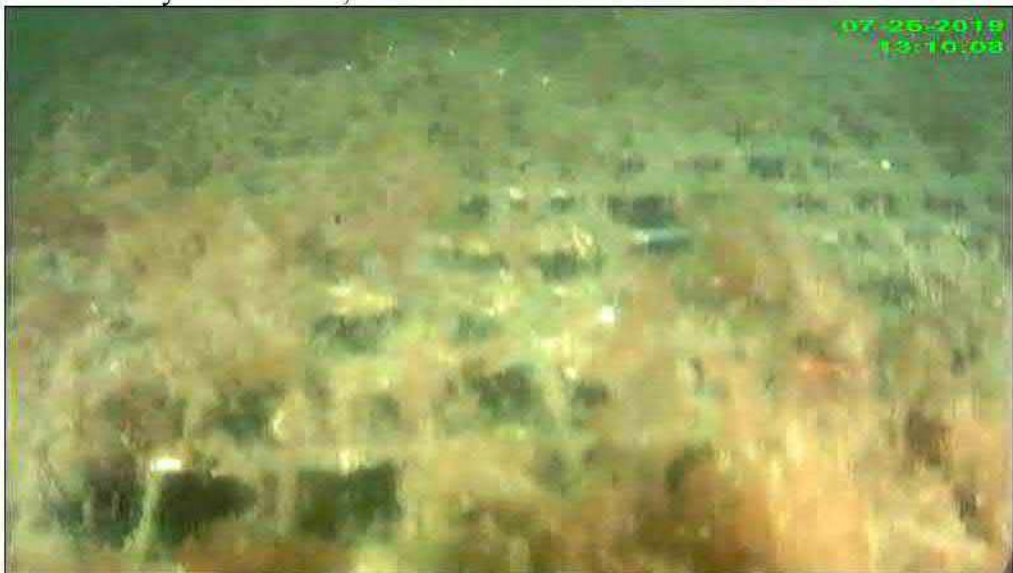
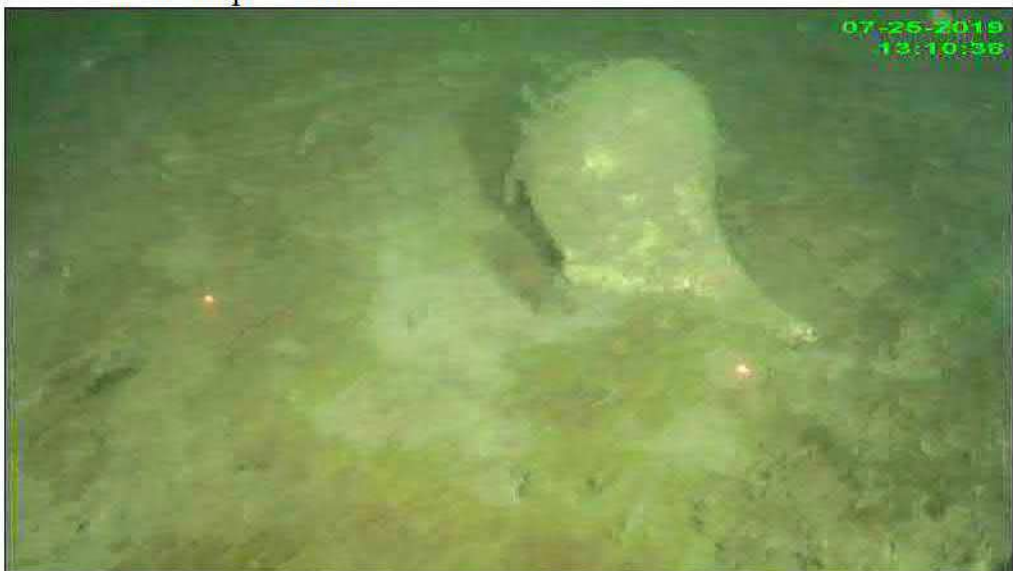
Muddy sand bottom, debris

Lobster trap remains

Muddy sand bottom with diatom mat, whelk

**Plate 14. Video Screen Captures of Bottom Substrate and Biota at TR-16 at the western nearshore end of the CVRR Pier**

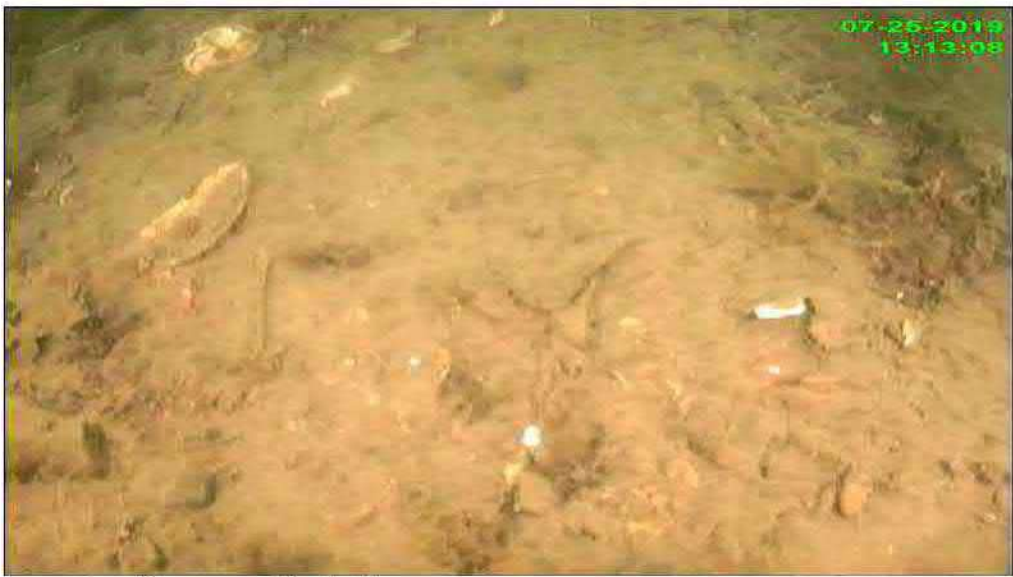
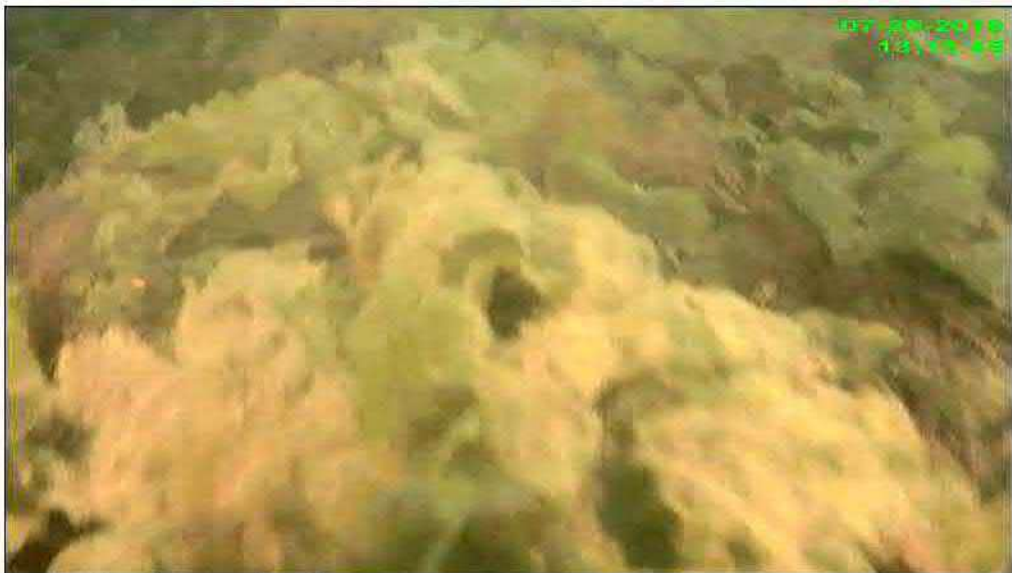
Sand bottom with shell

Sea lettuce abundant

Sea lettuce, red branching algae abundant

**Plate 15A. Video Screen Captures of Bottom Substrate and Biota at TR-17 along the Northwest Bulkhead**

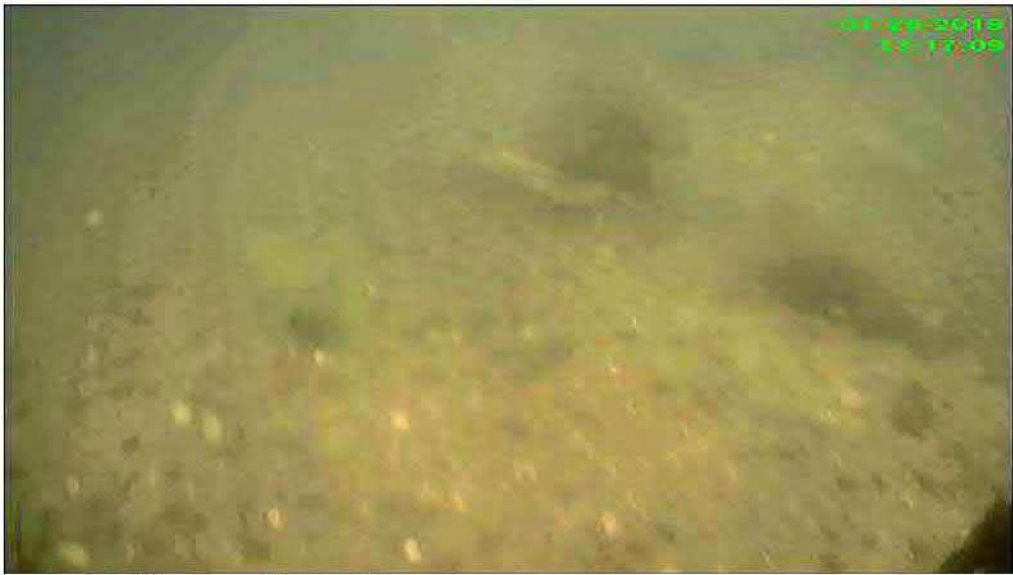
Sand bottom, Blue crab

Sea lettuce, red branching algae abundant

Boulder with macro algae

**Plate 15B. Video Screen Captures of Bottom Substrate and Biota at TR-17 along the Northwest Bulkhead**

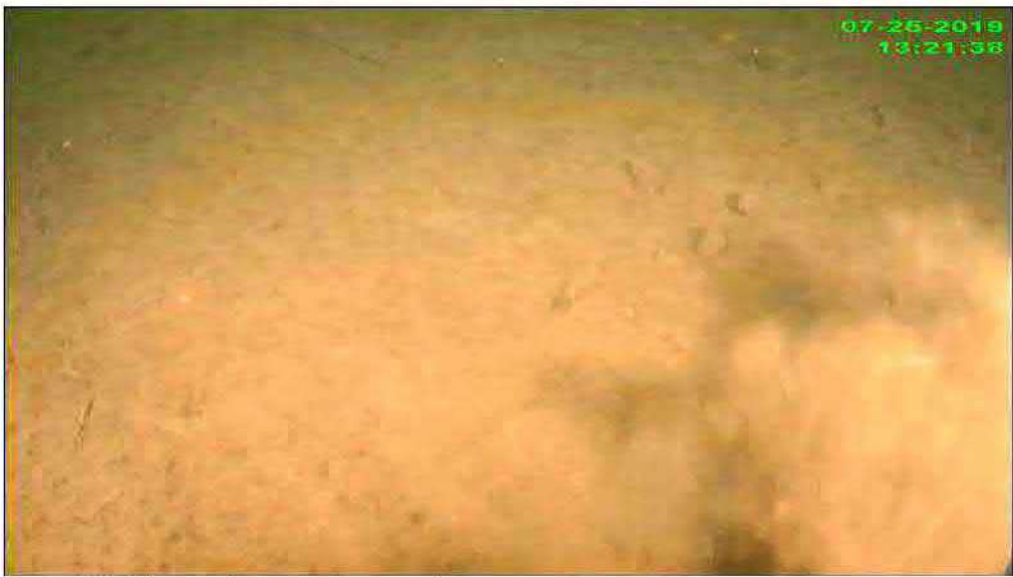
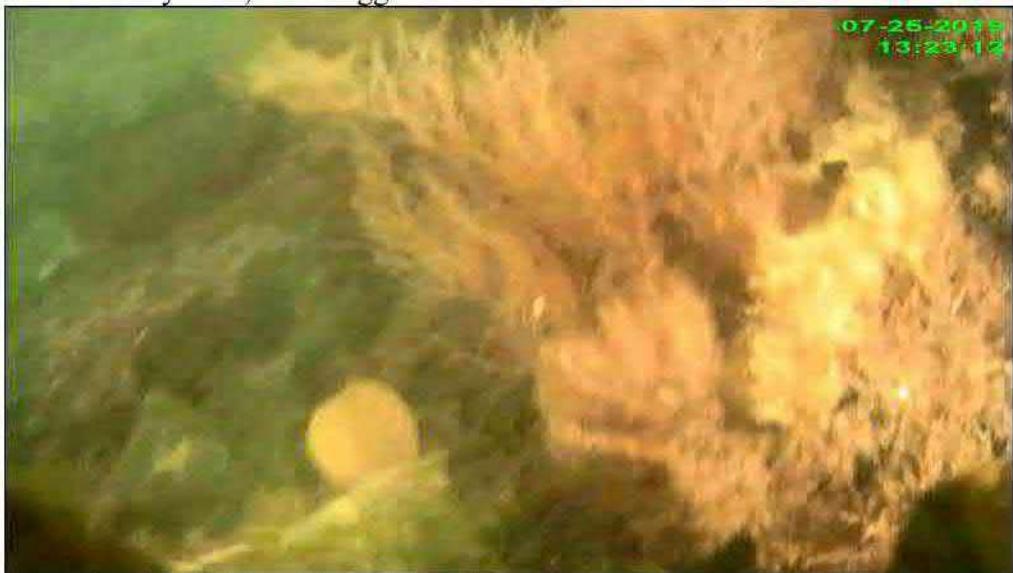
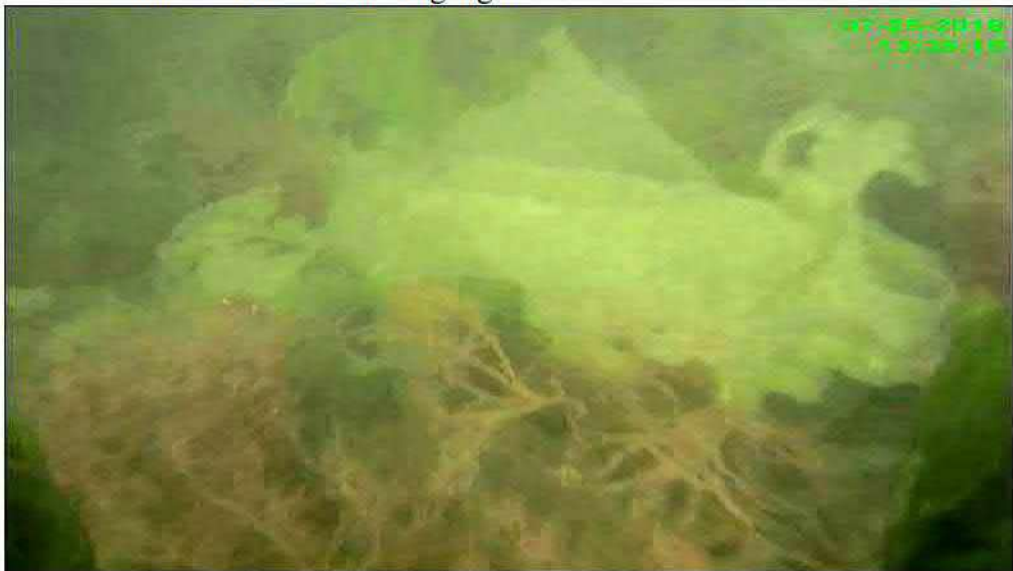
Muddy sand, worm egg sacks

Boulder with red branching algae

Sea lettuce, branching red algae abundant

**Plate 16. Video Screen Captures of Bottom Substrate and Biota at TR-18 along the Northwest Bulkhead**

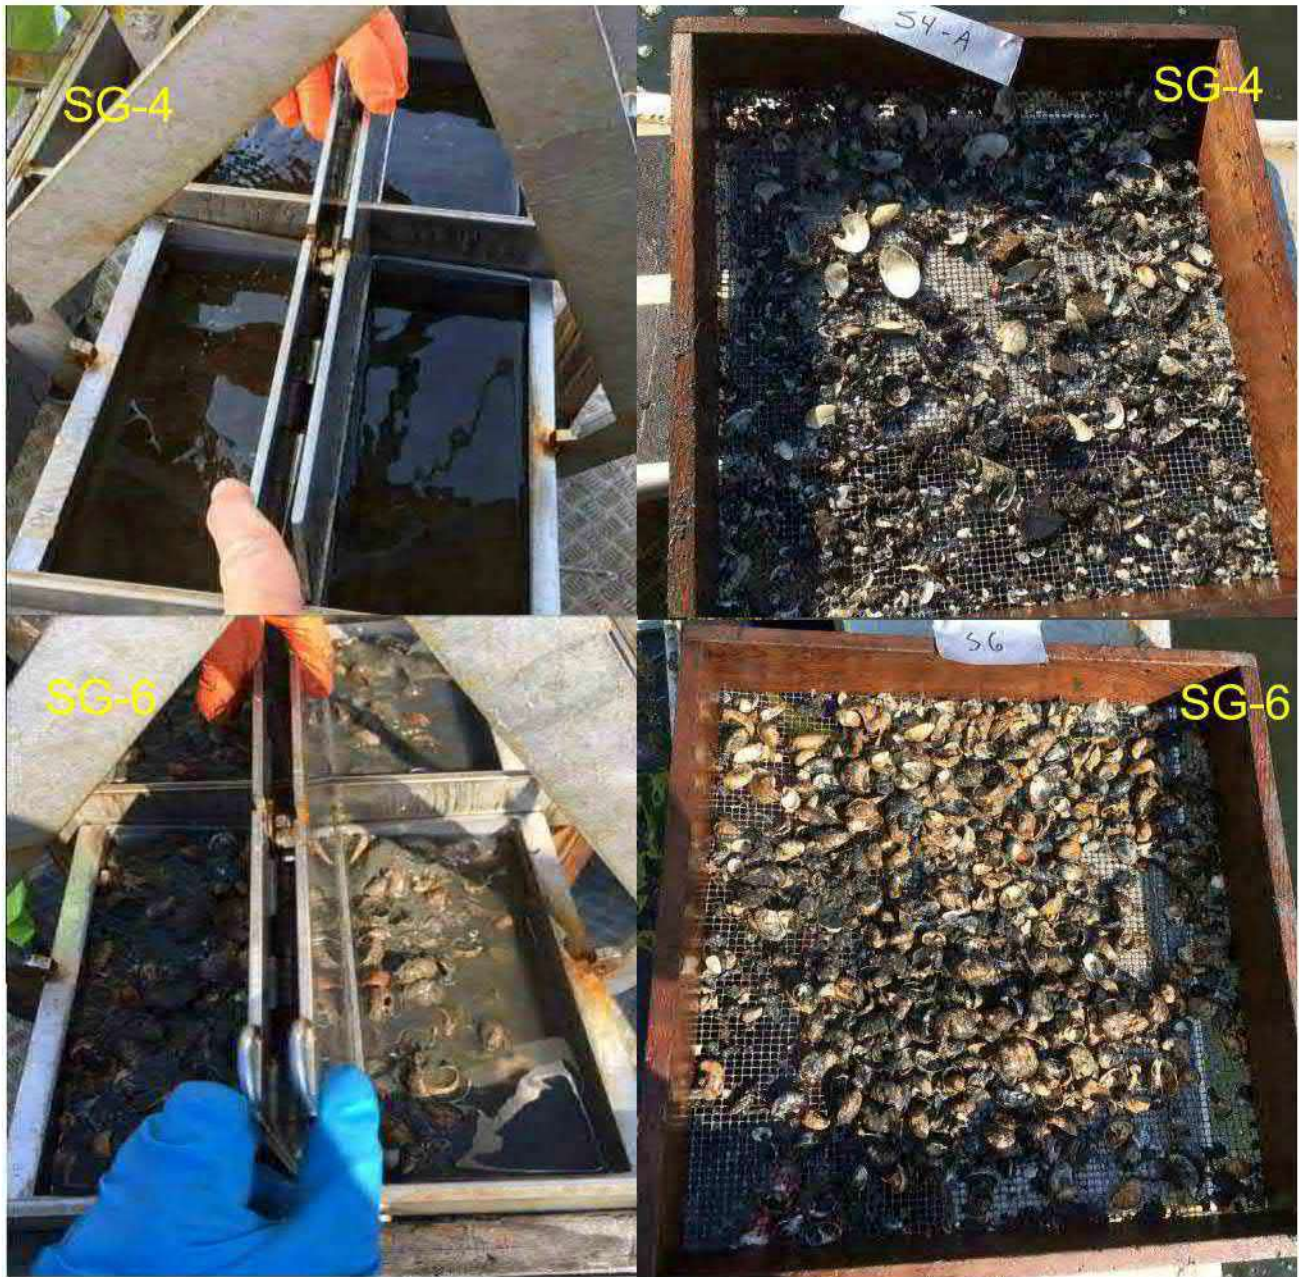
Plate 17. Shellfish Grab SG-4, SG-6 before and after processing.

Sample locations for shellfish habitat assessment are shown in **Figure 2-3**. Visual characterization of the subtidal shellfish samples collected with the Van Veen grab had sediment comprised of a mix of black, anoxic silt with a sulfidic odor and varying amounts of sand, clay, pebbles, and shell hash (**Figure 3-8**). Half of the intertidal shellfish samples (9) that were collected using the hand rake were from areas with small boulders and had no shellfish. The remaining shellfish samples consisted of a mix of pebbles and sand. Visual sediment characterization is shown in (**Figure 3-8**). A description of the visual sediment type is provided within **Appendix B**. Of the fifty-two (52) samples collected for shellfish habitat assessment, twelve (12) were found to have commercially important shellfish. Commercially important shellfish species were identified from 23% of the samples collected. There were thirty-one (31) quahogs, three (3) soft shell clams and twenty-one (21) blue mussels collected during the AECOM survey (**Figure 3-9**). More than half (62%) of the shellfish collected were from stations outside the Project footprint. Station SG-50 had eleven (11) quahogs and twenty-one (21) blue mussels, which comprised 58% of the total number of Commercially important shellfish collected. From within the project area, twenty-eight (28) stations were sampled with six (6) of these stations (Stations 17, 24, 42, 44, 47 and 48) having a combined total of thirteen (13) quahogs and one (1) station (Station 23) had two (2) soft shell calms. Shellfish measurements are provided within **Appendix B**. Reprehensive photographs from shellfish samples are within **Plates 17-22**.

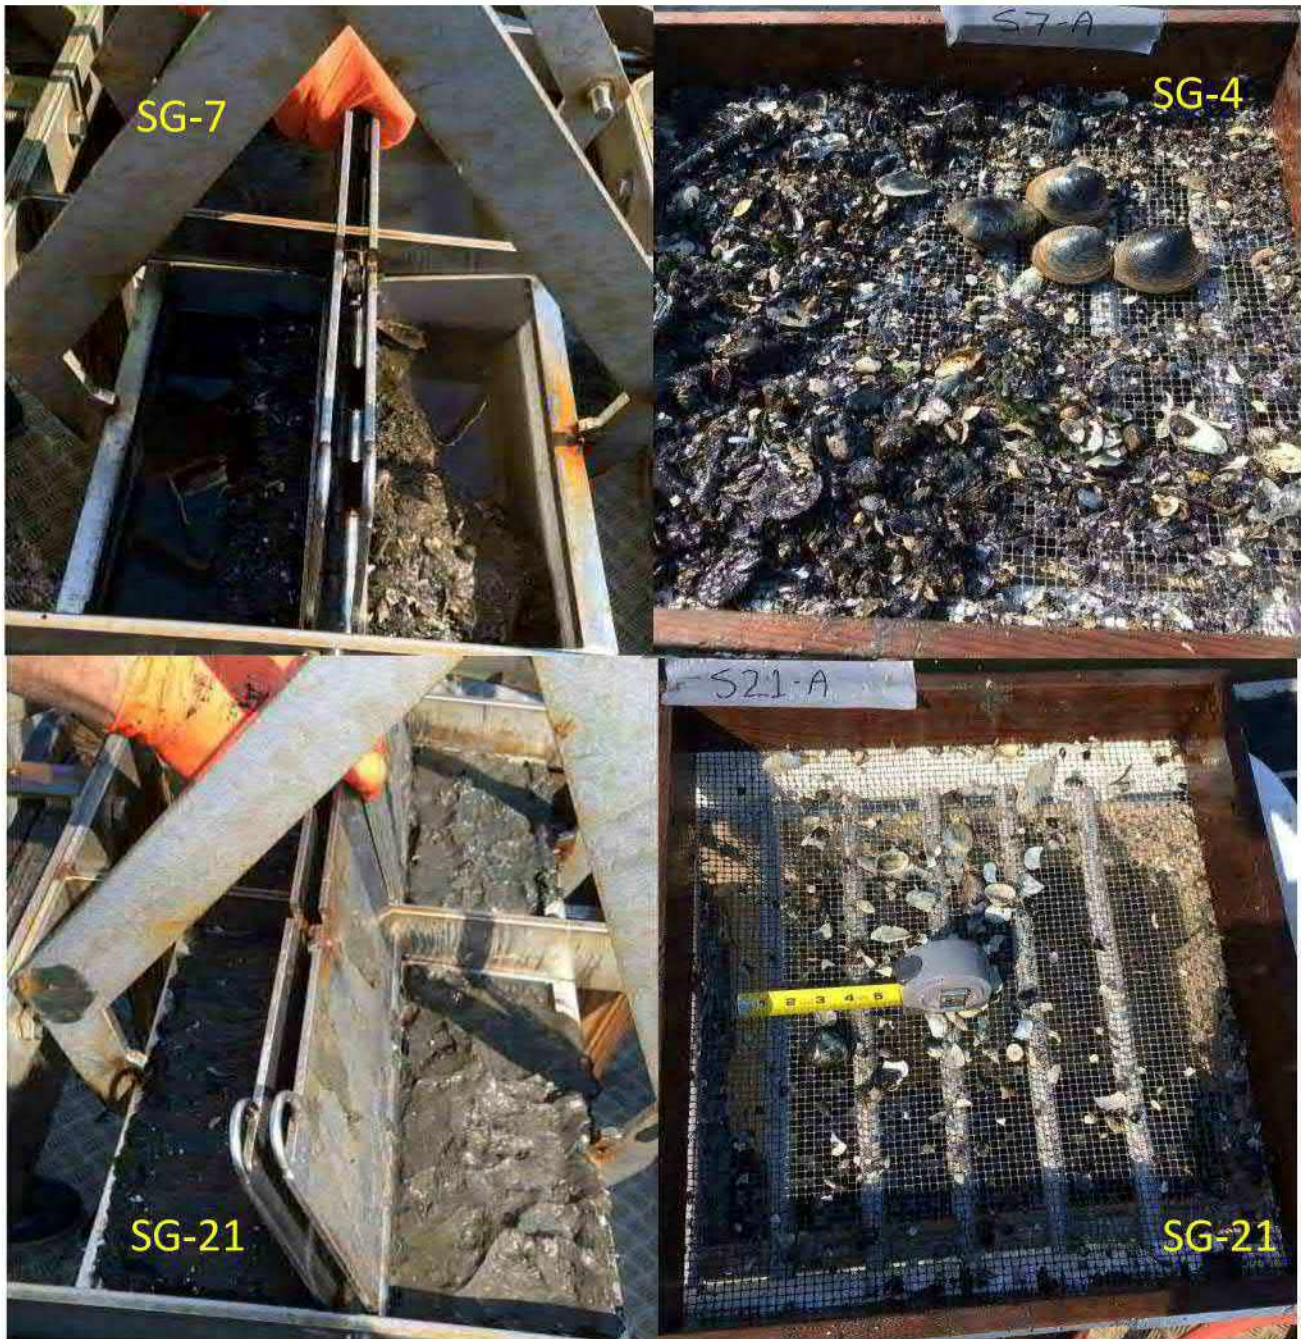
Plate 18. Shellfish Grab SG-7, SG-21 before and after processing.

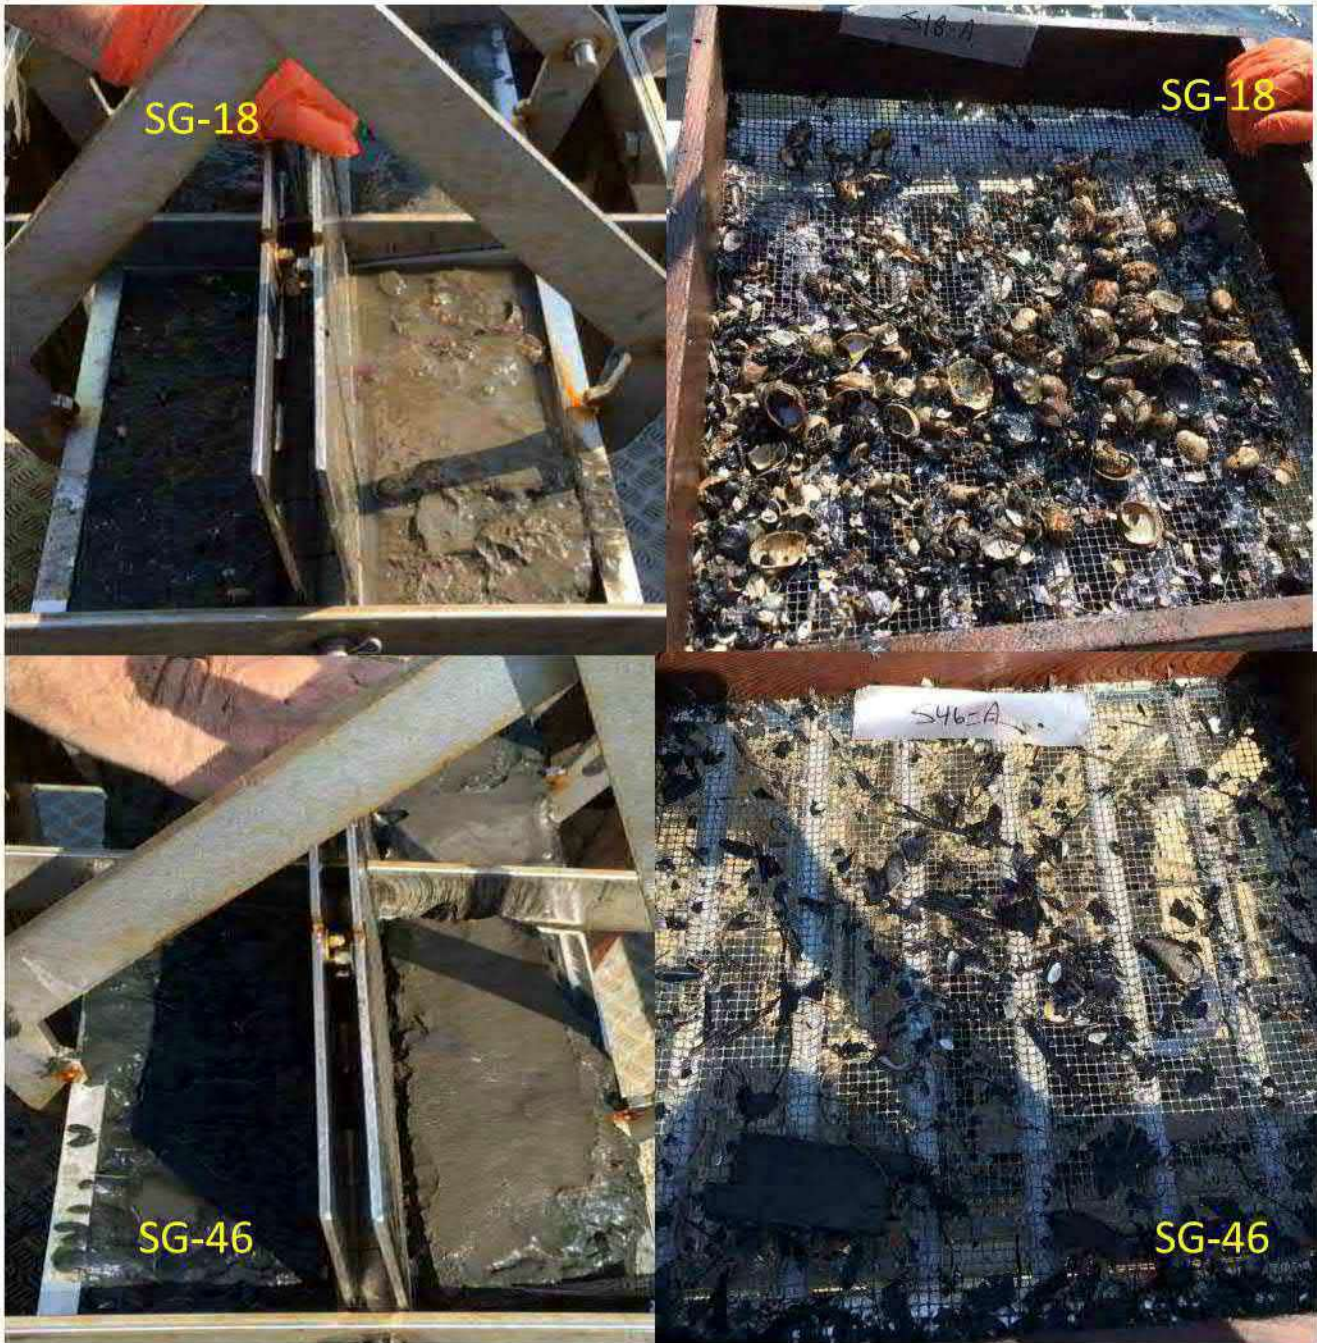
Plate 19. Shellfish Grab SG-18, SG-46 before and after processing.
