## BENTHIC HABITAT ASSESSMENT REPORT

In support of the Environmental Assessment for the  
State Pier Infrastructure Improvements Project

AECOM  
500 Enterprise Drive  
Suite 1A  
Rocky Hill, Connecticut 06067

October 2, 2019

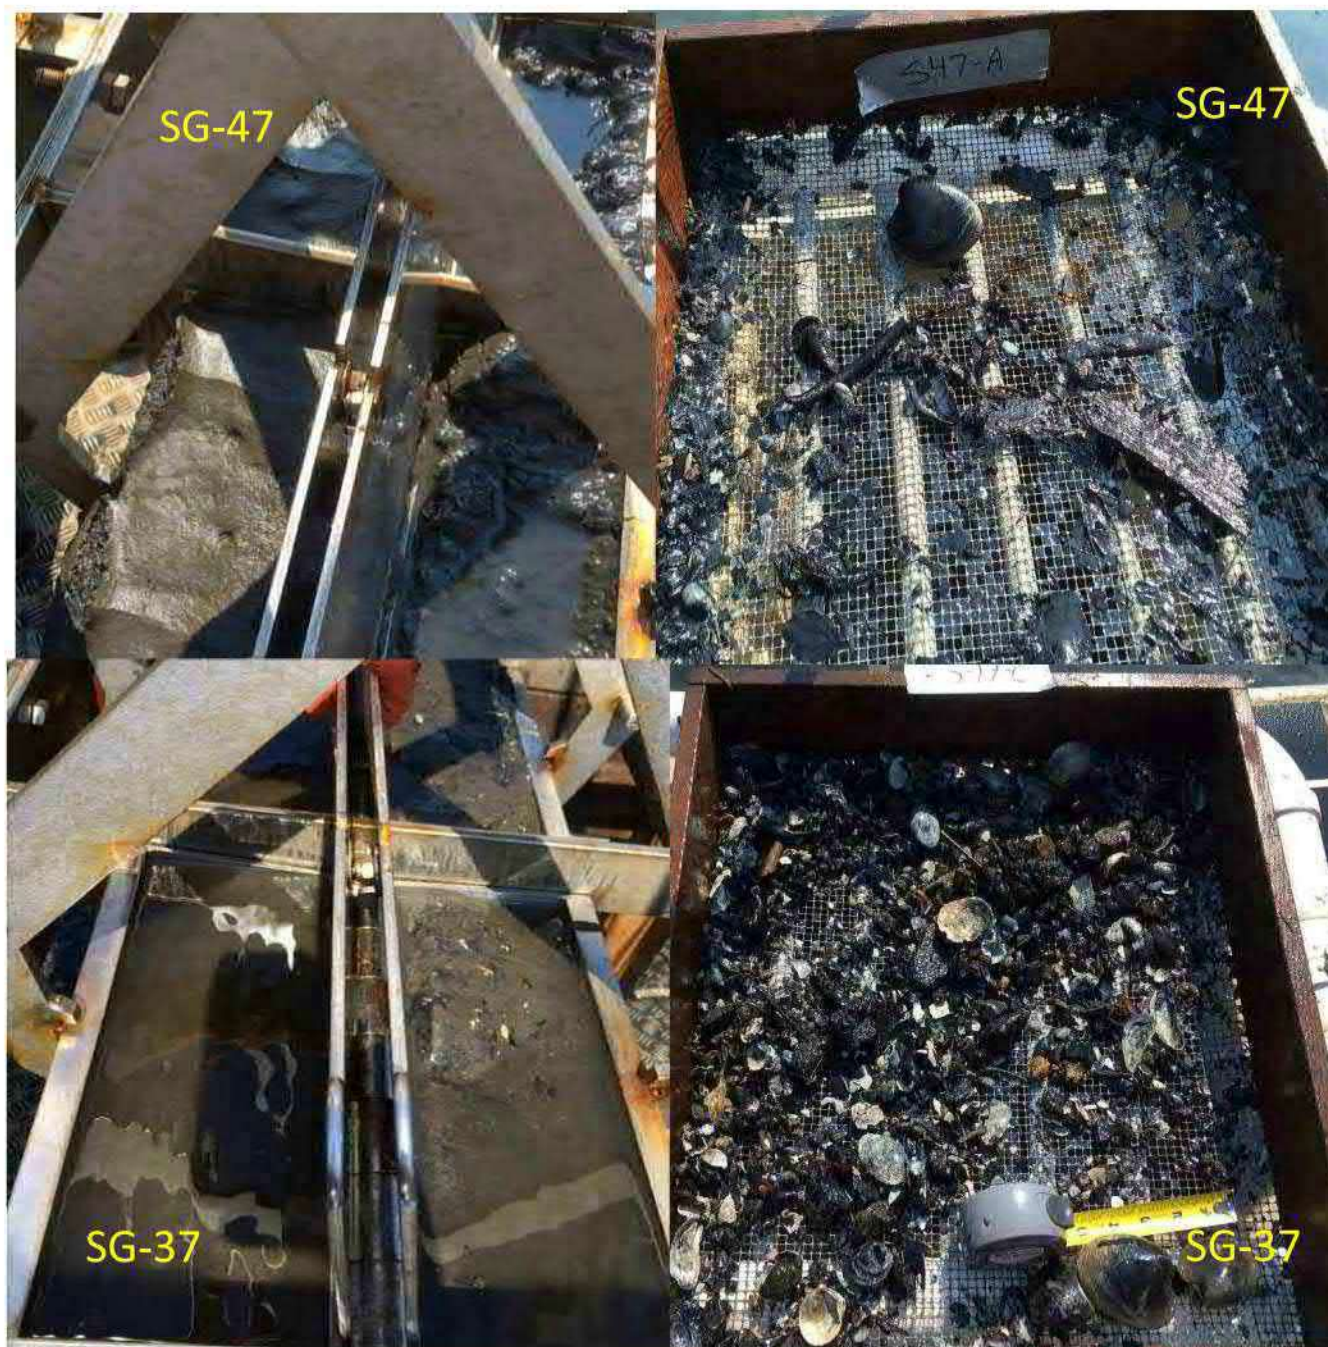
Plate 20.

Plate 21. Shellfish Grab SG-47, SG-37 before and after processing.

Sample locations for shellfish habitat assessment are shown in **Figure 2-3**. Visual characterization of the subtidal shellfish samples collected with the Van Veen grab had sediment comprised of a mix of black, anoxic silt with a sulfidic odor and varying amounts of sand, clay, pebbles, and shell hash (**Figure 3-8**). Half of the intertidal shellfish samples (9) that were collected using the hand rake were from areas with small boulders and had no shellfish. The remaining shellfish samples consisted of a mix of pebbles and sand. Visual sediment characterization is shown in (**Figure 3-8**). A description of the visual sediment type is provided within **Appendix B**. Of the fifty-two (52) samples collected for shellfish habitat assessment, twelve (12) were found to have commercially important shellfish. Commercially important shellfish species were identified from 23% of the samples collected. There were thirty-one (31) quahogs, three (3) soft shell clams and twenty-one (21) blue mussels collected during the AECOM survey (**Figure 3-9**). More than half (62%) of the shellfish collected were from stations outside the Project footprint. Station SG-50 had eleven (11) quahogs and twenty-one (21) blue mussels, which comprised 58% of the total number of Commercially important shellfish collected. From within the project area, twenty-eight (28) stations were sampled with six (6) of these stations (Stations 17, 24, 42, 44, 47 and 48) having a combined total of thirteen (13) quahogs and one (1) station (Station 23) had two (2) soft shell calms. Shellfish measurements are provided within **Appendix B**. Reprehensive photographs from shellfish samples are within **Plates 17-22**.

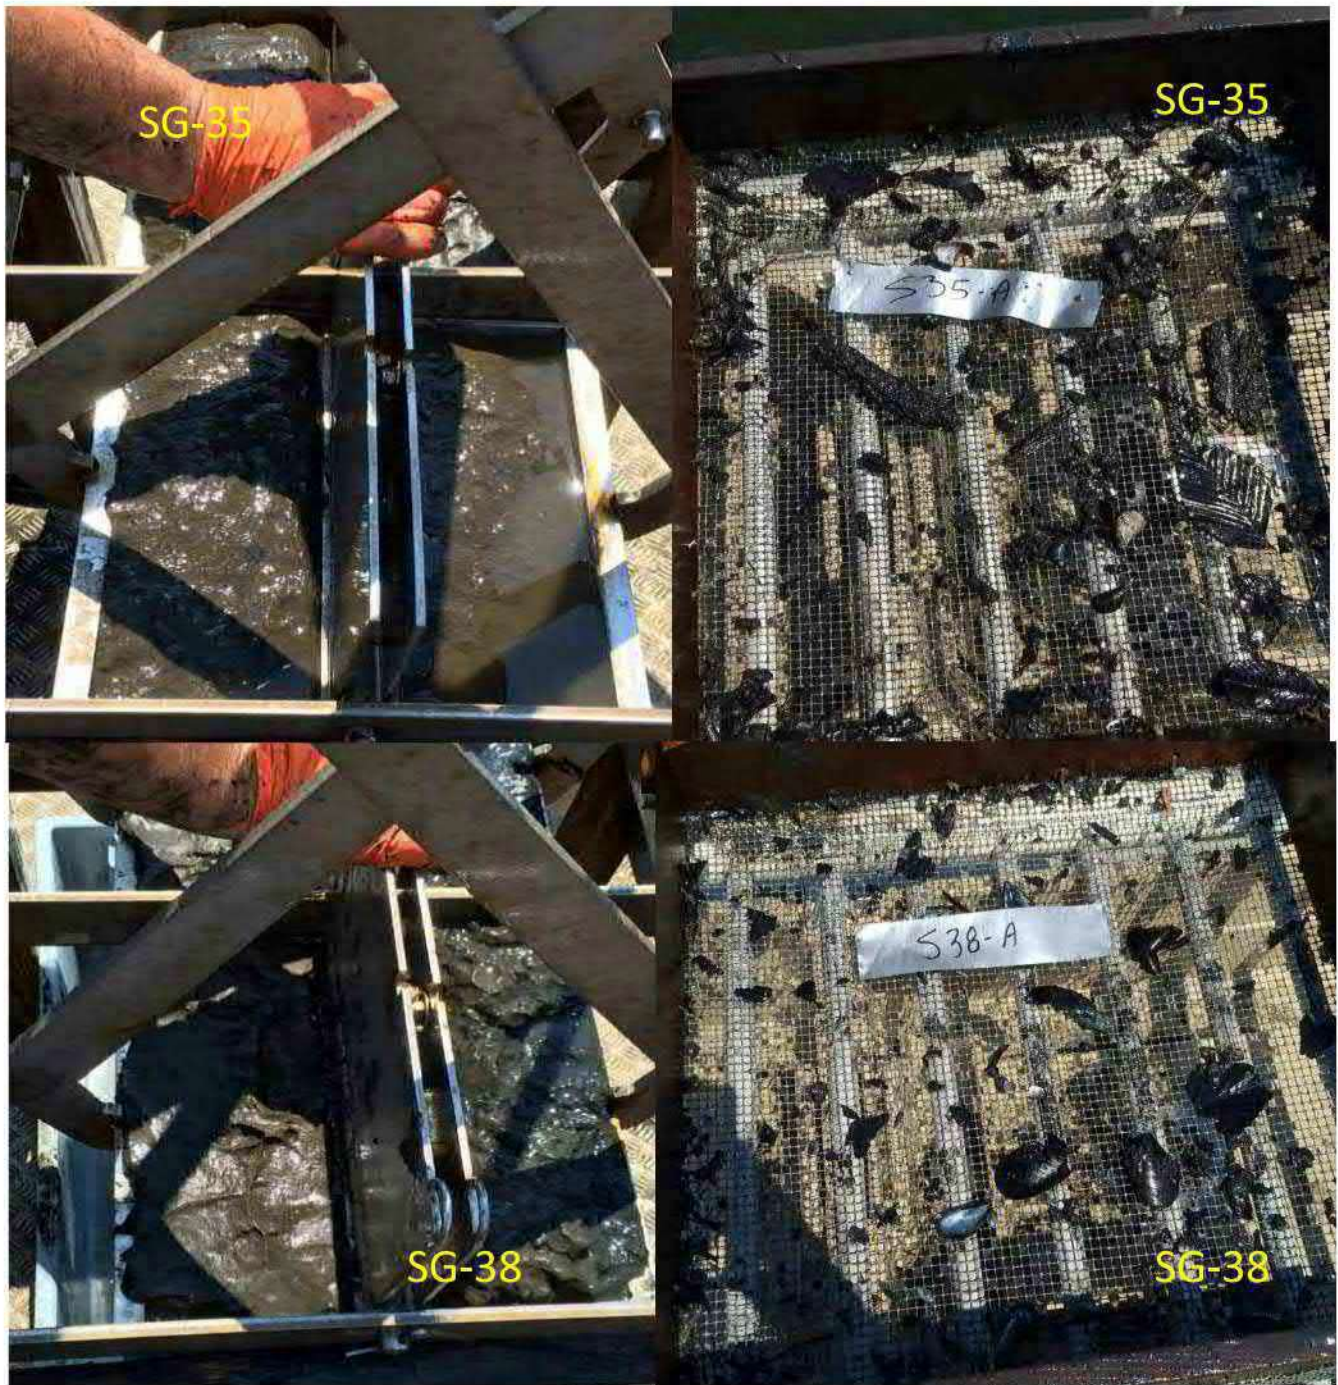
Plate 23. Shellfish Grab SG-35, SG-38 before and after processing.
